## Journal of Advanced Research in Fluid Mechanics and Thermal Sciences

# Establishing the Taxonomy of Building Defects Triggered by Moisture Intrusion and Dampness

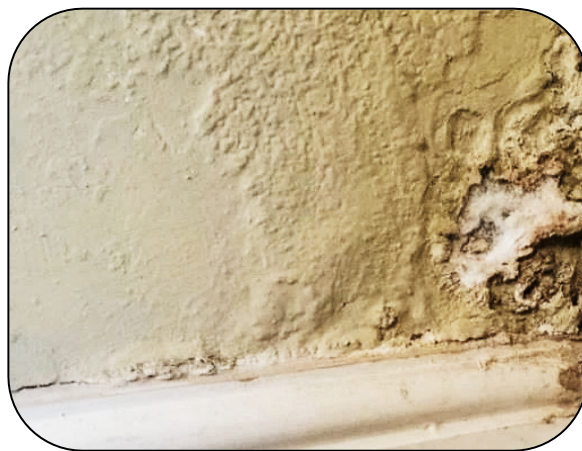
Groundwater infiltration often leaves a conspicuous stain on the wall, taking the shape of a tide mark. Additionally, you could observe the formation of salts on the inner surface. Moisture infiltration, commonly known as rising damp, is frequently linked to the detachment of paint and plaster. Externally, the mortar may deteriorate, and white salt streaks may become visible on the walls. Rising dampness exclusively occurs at lower levels, as the dampness that ascends the wall originates from the soil beneath it in the ground as shown in Figure 1. Decomposing skirting boards, deteriorating plaster, and water stains on sidewalls all indicate a potential issue with increasing moisture. Figure 2 demonstrates a profound dampness issue appeared at the internal wall.

**Fig. 1.** Indications of rising dampness appear at the ground level

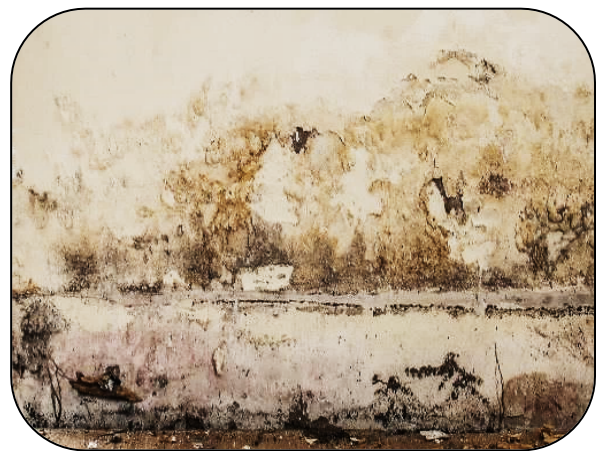
**Fig. 2.** A serious dampness problem occurred at the internal wall

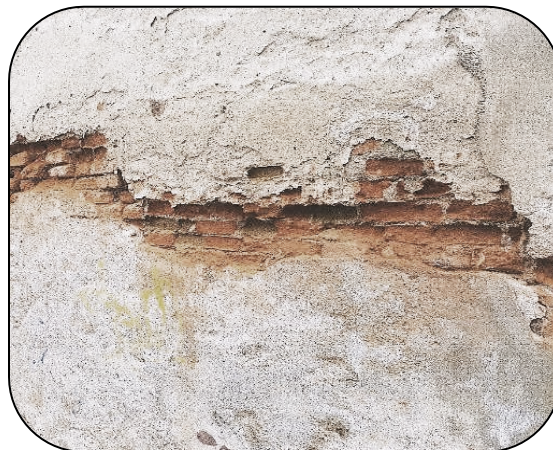
**Fig. 3.** Rising dampness occurred at external wall

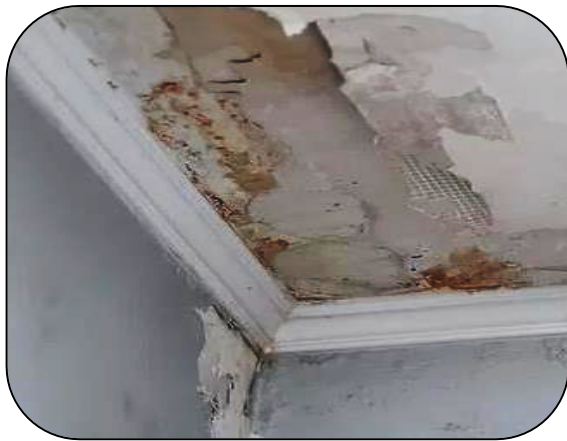
Falling dampness occurs when water infiltrates permeable brick structures from above, causing horizontal infiltration. This may be due to insufficient waterproofing of the topmost layer of a barrier (coping), malfunctioning flashings, clogged or leaky gutters, deteriorated plaster joints, and the accumulation of dust and vegetation on the top layer of masonry. Decomposed leaves, bird excrement, lichen, and soil contain mild salts and acids that, if transported by water into masonry, can accelerate deterioration [31, 32]. When it comes to flat roofs, improper rainwater pipe connections, insufficient roof slopes, and faulty roof slab-parapet wall couplings can all be the cause of moisture buildup and lead to falling dampness as shown in Figure 4.

**Fig. 4.** Falling dampness occurred due to improper rainwater pipe connections

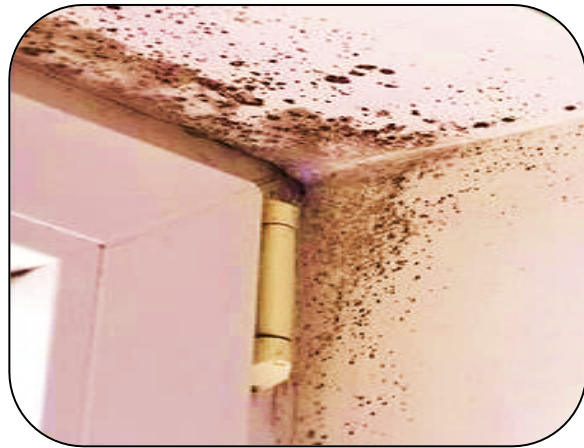
Rainfall that falls on the outside walls and parapets might lead to the occurrence of falling dampness as illustrated in Figure 5. If a sloped roof has a poor roof covering, rainwater may seep underneath. Moreover, defective gutters slope and eave or valley gutters might permit rainwater to seep down the upper load-bearing wall, resulting in moisture and dampness. Many building products, such as concrete, stones, or cement, include connected voids. When these elements make interaction with water, the water seeks a pathway to enter these empty spaces. Once again, the water is able to travel in many directions due to the action of capillary, resulting in the presence of falling dampness [33]. One should exercise caution when there is moisture in the area of electrical appliances, as it can cause the deterioration of electrical fittings and increase the likelihood of electrical leakage and the subsequent danger of short circuits [34]. Persistent moisture can facilitate the proliferation of harmful disease-causing microorganisms, including tuberculosis and neuralgia. Additionally, it can induce asthma in individuals residing in the building. Consequently, it is imperative to prevent and address dampness within the structure. To achieve this, it is crucial to identify the origins of the moisture, as it serves as the main trigger for falling dampness.

**Fig. 5.** Rainfall that hits the exterior walls and parapets caused falling dampness to occur

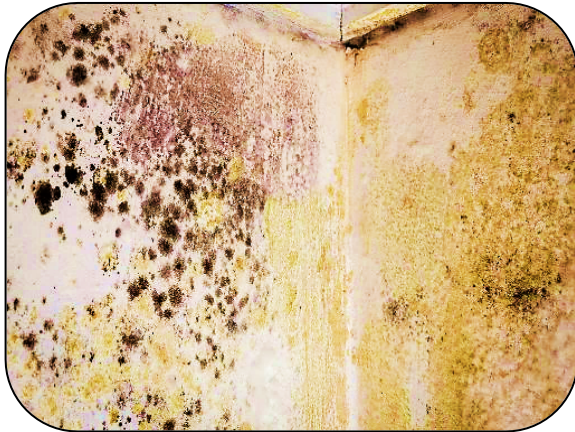
Penetrating dampness (Figure 6) pertains to the infiltration of water into a building's structure, typically due to an external flaw. Defects manifest in different forms, including degraded gutters, flawed pointing, permeable brickwork, poor roof textiles, or fractured and shattered plaster. During rainfall, the moisture often escapes off the masonry or concrete surfaces [35]. Nevertheless, under specific conditions, such as during instances of intense precipitation or when the building has an exterior flaw (as previously described), the moisture is unable to go away and instead seeps through to the interior surfaces.

**Fig. 6.** Penetrating dampness connected to water intrusion into a wall element

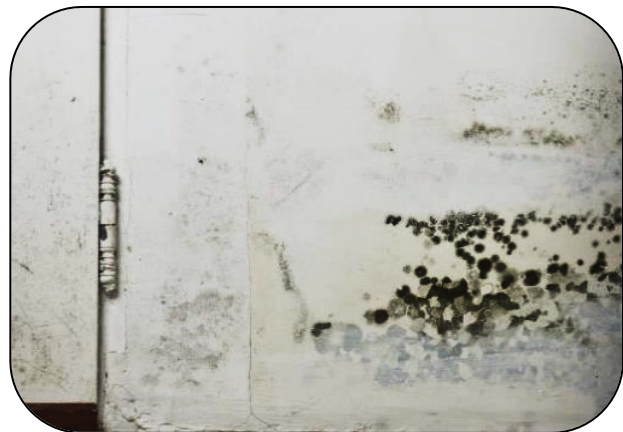
**Fig. 7.** Presence of black mold on internal wall surface

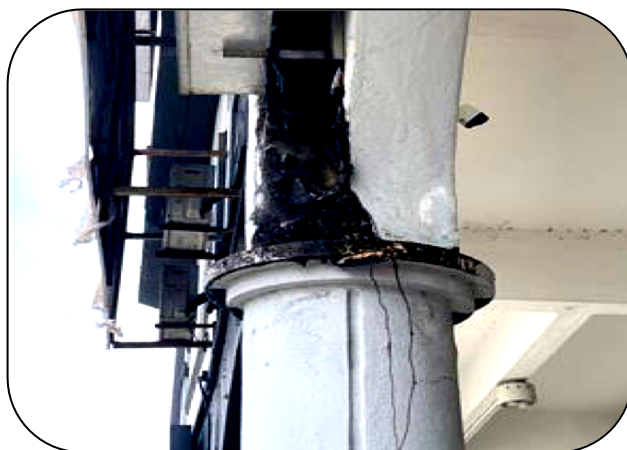
**Fig. 8.** The presence of fungus and moss in moist environment would gradually lead to erosion

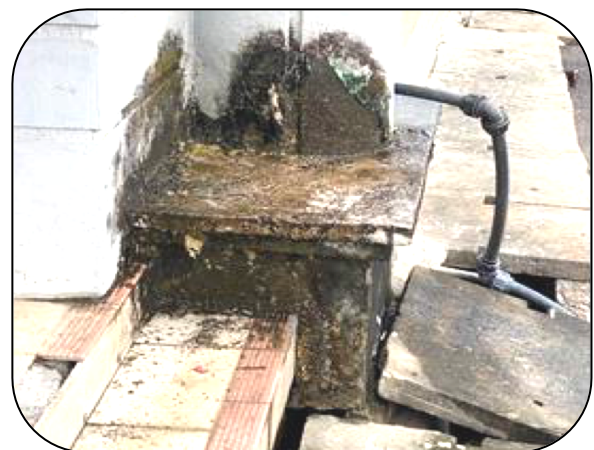
The mold and its spores emit an unpleasant smell commonly linked to a moist dwelling. The presence of salt deposits inhibits the growth of black mold, such as in cases of rising dampness. Consequently, the occurrence of black mold indicates the presence of condensation dampness. Condensation dampness can strike due to the existence of air conditioning water and rainy weather in the building [37]. Permitting the proliferation of fungus and moss under damp conditions would gradually cause erosion as proved in Figure 8. The presence of moisture on the building walls is produced by the lack of proper drainage for the air conditioning water. This leads to the growth of organisms such as fungi and moss, resulting in wall dampness as exhibited in Figure 9.

**Fig. 9.** Growth of organisms including moss and fungi

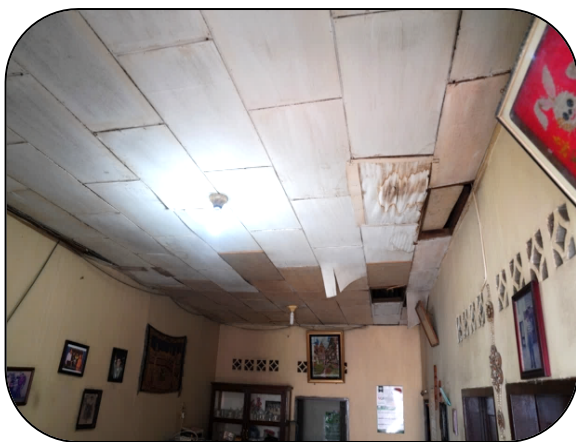
Numerous instances of water leakage have been reported, encompassing both leaks from ceilings (Figure 10) and breaches from floors (Figure 11). These might arise from the walls or ceiling of residential or commercial buildings, resulting in unsightly molds and persistent stains developing on the surfaces. This leakage could perhaps originate from your upstairs neighbor or even within your own unit. Water has the ability to seep through minuscule, imperceptible fissures that you may not have considered to be present in the walls and ceilings within the house, as well as in unforeseen areas such as the electrical conduit. Frequently observe a substantial expanse of discoloration and fungus on your ceiling or bathroom walls, this is a distinct sign of the gradual buildup of wastewater due to water leakage. Figure 12 shows the water leaking through the floor. Water leakage issues might arise, particularly during heavy rainfall, when there is a roof directly above or when there is a balcony with a break on the side, allowing rainwater to infiltrate.

**Fig. 10.** Water seeping through the ceiling

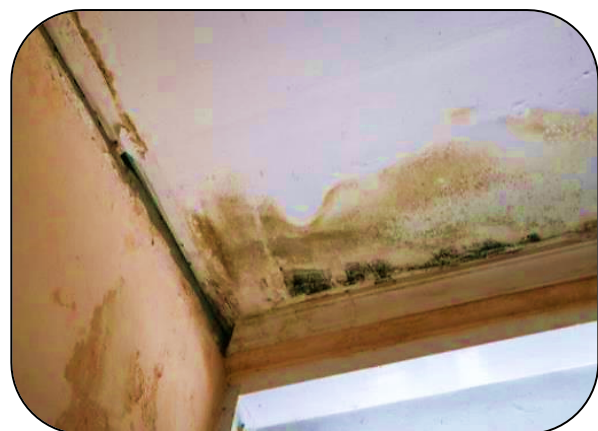
**Fig. 11.** Seepage resulting from breaches in the flooring

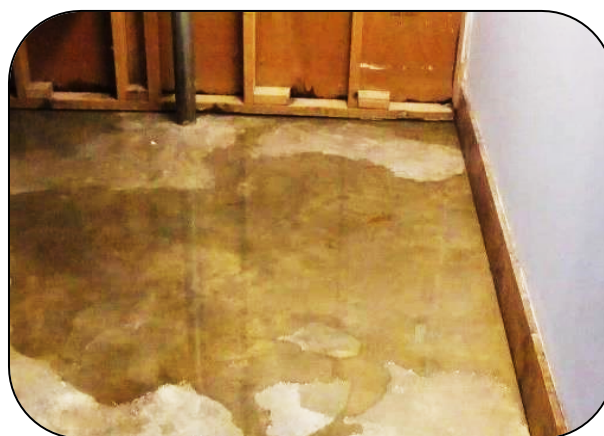
**Fig. 12.** Water seeping through the floor

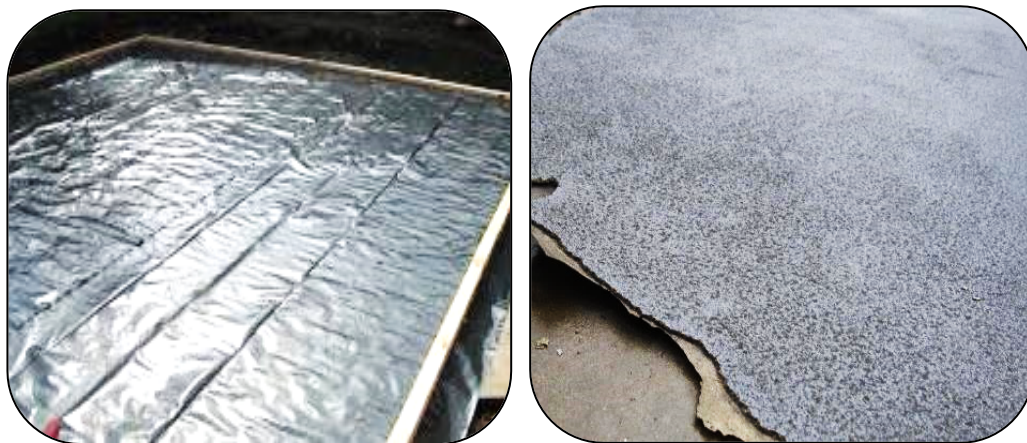
Waterproof membranes offer a convenient and economical solution when a building exhibits indications of damage caused by water. Waterproofing involves various factors and procedures to guarantee optimal durability and longevity for both the building and its occupants. Regrettably, malfunctions in the waterproof membrane can have a catastrophic impact on the structural soundness of the building, pose health hazards to inhabitants, and escalate the overall cost of maintenance [38]. Inadequate overlapping of the waterproofing membranes might result in the infiltration of rainfall via the gaps. In addition, incorrect incline, faulty connections between the roof slab, terrace, and wall parapet, and obstructed drainage systems can also cause water accumulation, leading to moisture problems. Figure 13 displays a defective waterproofing membrane

**Fig. 13.** Defective waterproofing membrane

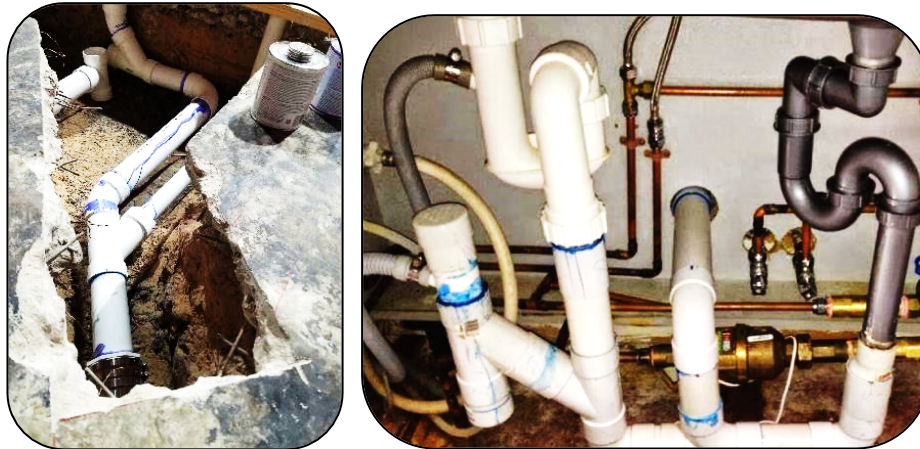
Inadequate plumbing arrangement in buildings can result in the occurrence of leaks and moisture issues over time as shown in Figure 14. If the threaded adapter of a plumbing fitting is positioned within the tiles, the installation necessitates the use of an extension piece. This introduces an additional connection in the pipeline, which has the potential to result in the escape of fluid. In addition, the usage of UPVC piping in a hot water pipeline is an instance of an inappropriate selection of material based on its qualities. Under such circumstances, the material which lacks the ability to endure elevated temperatures will initiate a process of deterioration and disintegration, resulting in the occurrence of leaks [39].

Moreover, the utilization of an incorrect solvent-material for connecting pipes might also contribute to plumbing malfunctions. For instance, when pipes are composed of UPVC, it is necessary to use a solvent or adhesive that is compatible with UPVC. The same principle applies to CPVC pipes. Any lack of compatibility in this situation can result in the escape of liquid or moisture due to a less secure connection. Failure to apply sealant at the intersection surrounding the bathroom floor sink outflow pipeline will result in the diffusion of dampness. This could eventually end in unsanitary and unclean circumstances for people and can cause degradation of the surfaces below the ceiling over

time. Leakage or moisture problems can often be attributed to loss of plumbing fittings or inadequate tightening of plumbing fittings, as well as bad labor during placement.

**Fig. 14.** Improper installation of plumbing

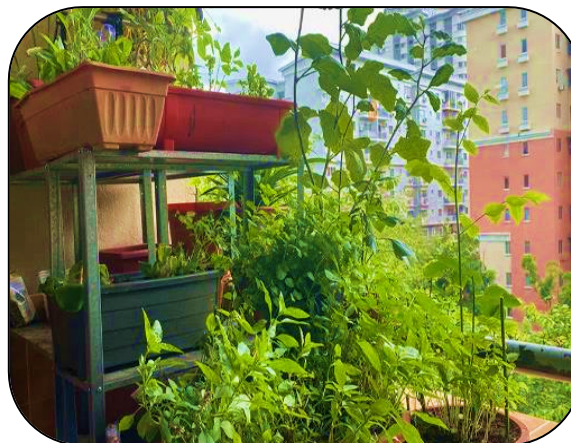
Houseplants may lead to serious dampness problem. Transpiration is the mechanism by which plants transfer moisture into the air through microscopic pores called stomata on their leaves as exhibited in Figure 15. This elevates the level of humidity in the interior atmosphere. However, not all plants have the ability to increase humidity. Furthermore, it is essential to determine the appropriate amount of water to provide to your potted plants in order to prevent them from emitting excessive moisture into the surrounding atmosphere. Gaining some expertise in indoor gardening can enable you to prevent moisture in your dwelling while simultaneously promoting environmental friendliness and sustainability [40].

**Fig. 15.** Indoor plantations

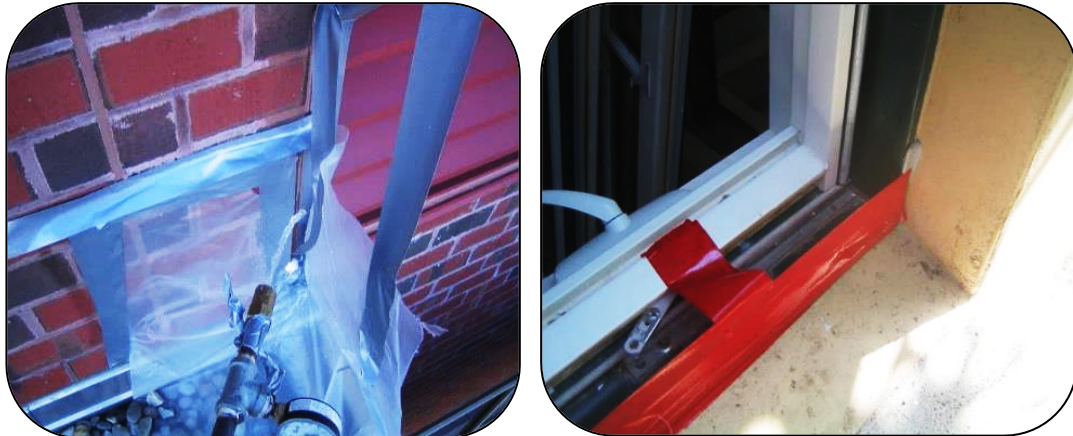
Occasionally, inferior supplies for construction are utilized during the building process, resulting in potential problems with the overall quality of the construction as shown in Figure 16. For instance, if substandard materials such as sand with excessive salt content are utilized, efflorescence will

inevitably occur at some point [41]. Inferior bricks will expand as they collect rainwater, resulting in moisture and dampness.

**Fig. 16.** Inferior materials and components can lead to dampness problem

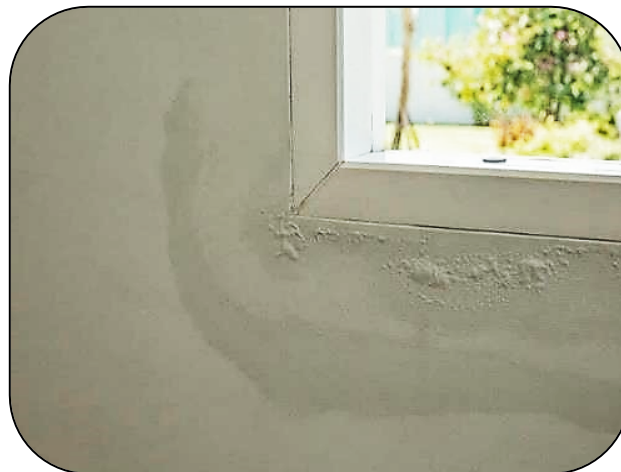
The primary cause for destruction within dwellings is typically water infiltration resulting from openings within the window frame and the wall on the outside as shown in Figure 17. The opening will serve as a conduit for moisture to enter the house. Inadequate filling of voids can result in the infiltration of moisture, corrosion of paint, and harm to the interior walls. Moisture infiltration may occur in the absence of a fillet or drip mold. If the paint applied to the outer wall lacks water-repellent properties, moisture might accumulate underneath the layer and gradually spread interior. In both instances, the walls on the outside rapidly disintegrate as a result of dampness.

**Fig. 17.** The intrusion of rainwater through window and wall

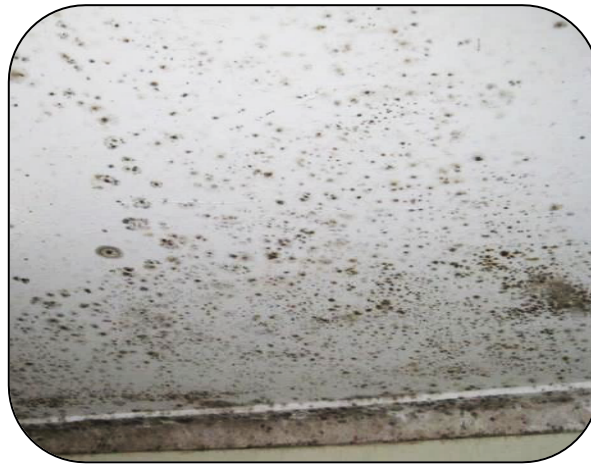
Inadequate ventilation in the residence will inevitably lead to the presence of dampness and mold growth as shown in Figure 18. Various activities such as breathing, cooking, and using the hot water dispenser in the restroom contribute to the humidity levels in the interior air. When the area is sealed

off, the surplus moisture becomes retained. It is essential to have adequate air circulation in the house to keep an optimal humidity level and prevent any decline in the quality of indoor air.

**Fig. 18.** Presence of dampness and mold growth due to inadequate ventilation
