Journal of Advanced Research in Applied Mechanics

Identification of Structural and Non-Structural Defects of Load-Bearing Wall Systems in Low Rise Buildings

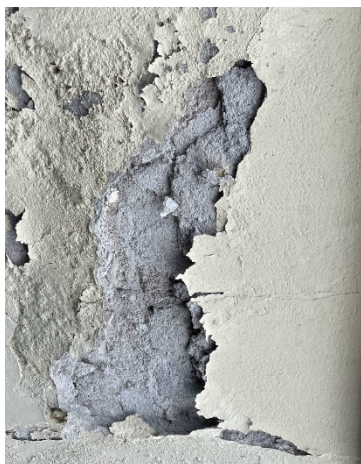
As can be seen in Figure 1(a), major cracks in building walls are among the major structural defects attributed to weather-related factors, especially extreme temperature fluctuations and high humidity. The major reason for these cracks is normally due to the thermal expansion and contraction going on with various building materials that expand when the temperature is extremely high and contract in cold conditions. This repeated movement over time weakens the structural strength and causes major cracks in the walls. High humidity thus exacerbates this by increasing the level of moisture within the materials to go through more expansion and contraction cycles. It is this kind of stress, combined with other possible factors like bad construction practices or degradation of the materials, that eventually leads to the visible hazardous cracks described by Verstryngge *et al.*, [25]. These issues are addressed by in-depth knowledge of local climate conditions and construction techniques for handling thermal movement and moisture control.

(a) Major cracks

As can be seen in Figure 2(a), Major wall cracks may require strong structural repairs for stability and durability. Epoxide or polyurethane injection is done to seal bigger cracks [35]. This is effective

since the injected materials seal tightly and bond well with the damaged surfaces, thus offering durable repairs. In other cases, metal reinforcement is needed, mostly in serious structural problems, before the crack is sealed off. This is simply done by running metal bars or a mesh across the crack to give more strength to the structure of the wall for it to stay together in one piece and not give way. Once this foundation of reinforcement is built, then the injection material of choice will be used to fill the crack, adding more strength, and avoiding such happening again. It, therefore, offers a solution not only for the superficially apparent damages but also strengthens the structure against future stresses, and environmental elements, and ensures long-term building stability.

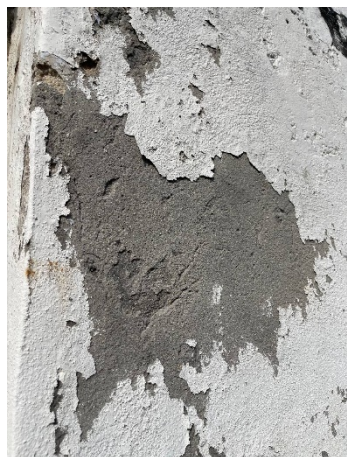
As shown Figure 1 (b), peeling paint is common and is influenced by a few environmental factors related to moisture, temperature changes, and failure to prepare the surface properly before painting. Then, depending on the high level of humidity or direct water exposure of the walls, some amount of moisture drawn into the layer of paint and substrate can occur, which reduces the bonding force between paint and wall surface. These temperature changes make the wall and paint expand and contract at different rates, causing stress that further compromises this bond. Also, if the wall surface has not been properly cleaned, primed, or dried before painting, the paint, in the first instance, adheres poorly. With time, these stresses and weaknesses appear in the form of cracking, peeling, and detaching of paint from the surface, thereby spoiling the aesthetic appeal and rendering the wall prone to damage by the environment. Therefore, due care must be taken for proper surface preparation and the right materials specified for bearing the specific environmental conditions [26].

(b) Peeling Paint

High-performance, weather-resistant paints are very important to aesthetic appeal and durable protection of painted surfaces. Paint formulations of this kind are fabricated from ingredients that can withstand moisture and changes in temperature and ultraviolet exposure from the sun [36]. The application of at least two coats will give more durability and lifespan to the painted surface. One coat provides an even cover over the surface and builds a foundation, and another one enhances the hold of paint on the surface. This double application at one go not only enhances the strength of adhesion of paint to the substrate to prevent peeling and cracking but also enhances the visual beauty with an even and glossy finish. Furthermore, proper surface preparation for painting requires cleaning and priming where necessary for a paint system to develop the required adhesion and performance. Those types of practices can gain aesthetic satisfaction and long-term protection against painted surfaces from environmental elements.

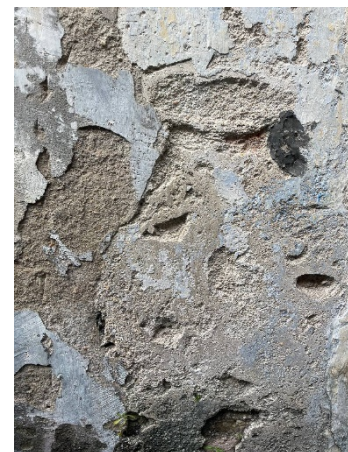
As can be found in Figure 1 (c), concrete surfaces become rough, uneven, and worn due to several environmental forces and regular use. Environmental exposure is a major cause of deterioration of the concrete, meaning weathering by winds, rains, and changes in temperatures. The winds wear down the surface, with rainfall adding water that infiltrates into it, while at low temperatures it freezes, causing internal damage. Temperature change expands or contracts the concrete, which can be the cause of cracking and roughness on the surface. Other factors, such as physical usage like foot or vehicular traffic further hasten the trend. All these effects result in an aesthetically unpleasing

concrete that appears rough and worn out [27]. More importantly, it has underlying risks to its structural integrity in the long run. Proper maintenance and protective measures must therefore be taken seriously to reduce these effects on concrete surfaces and increase their lifespan.

(c) Old Concrete Wall Texture

When concrete surfaces become pitted, spalled, or uneven-looking, this concrete resurface solves it with great adhesion to any existing concrete for renewed uniformity and durability [37]. First, prepare a clean surface that is free of debris. Mix the concrete resurface overall rough or pitted areas, as instructed in the mixing and application directions of the packaging. Apply the resurface using a trowel, spreading it evenly and at the right thickness to fill in the gaps and even up the surface. Allow the resurface to be partially set; this follows the instructions of the product applying and levelling it. Finish with a smooth finishing layer over the resurface for a sleek and even finish in surface texture. This not only restores the façade of concrete but also enhances any loss of structural integrity to make sure it looks great and stands strong for years.

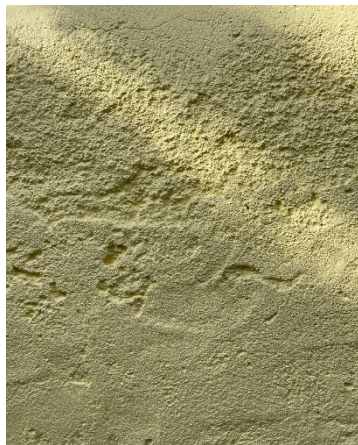
As illustrated in Figure 1 (d), Efflorescence is a crystalline deposit of salt, often, on the surface of masonry and is undesirable both aesthetically and functionally. It could be a result of poor workmanship in building or bringing a building to completion. Poor preparation of the surface, improper laying on plaster or paint, and poor finishing are common causes that bring about uneven wall surfaces and can easily lead to efflorescence. When these salts are dissolved by moisture and come to the surface, they form white, powdery stains that can mark their appearance on the wall [28]. From a functional perspective, efflorescence can serve as an indication of deeper moisture problems that, someday, may compromise the building materials. Proper construction methods from appropriate surface preparation to high-quality finishing materials go a long way to preventing this problem on its own.

(d) Efflorescence

As can be seen in Figure 2(b), a penetrative sealer should be applied to avoid the infiltration of water and to safeguard the surfaces of the wall. It is a sealant that can penetrate deep into the very effectiveness of the porous surface of the wall material, ensuring long-lasting waterproof characteristics [38]. Clean and dry the surface of the wall before applying the sealant. Apply a penetrating sealant by use of a brush, roller, or sprayer on the surface area of the wall, making sure that the whole surface area has been sufficiently covered. Allow the sealer to soak in and dry according to the manufacturer's instructions. Applied, the sealant creates a repellence barrier that repels water and minimizes the damage from water, mould growth, and efflorescence the white, powdery residue originating from salt deposits. Such a periodic maintenance program relating to the

reapplication can result in continued effectiveness over time to retain the integrity and appearance of the wall surface.

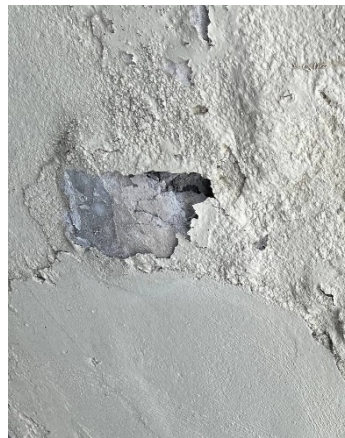
Figure 1(e) shows the cracks, these holes in walls are mostly explained by moisture damage or by differences in the moisture content of these construction materials. Water intrusion can lead to the formation of such holes in several ways. Water can enter the wall structure through leaking plumbing or roofing, inadequate waterproof coatings, and an absence of, or deficiency in, damp-proof courses [29]. In the case of prolonged wetness, this is very well developed, leading to the degradation of the material and the formation of holes. Water enters the wall, weakening the structure of the wall, whereby plaster or drywall falls apart to form holes and cavities. Proper waterproofing, maintenance, and timely repairs can prevent or help one avoid the occurrence of such moisture-caused damage.

(e) Holes

Clean any holes in the wall very well so that no loose material, be it dust or dirt, remains within them, as this is a preparation needed to have the patching of these areas glued well to their surface. After cleaning the holes, fill them up with an appropriate patching material. Take some cement-based filler to fill them, and with that, the repair will have good strength and hold well on the surface of the wall. Apply this patching material using the pallet knife or trowel; push it firmly into the holes and out flat to lie even with the surrounding surfaces. Allow the filler to dry completely according to the manufacturer's instructions before lightly sanding the patched areas. This rectification method not only reinstates the integrity of the wall but also ensures a neat, professional look at the repair that will completely blend in with the existing surface [39].

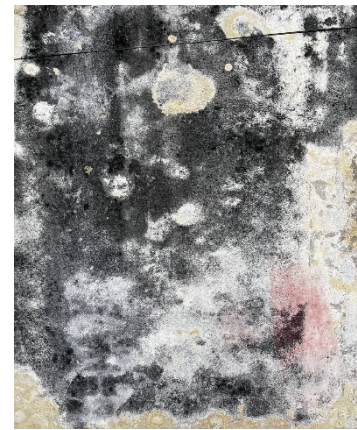
As can be seen in Figure 1(f), High-level humidity or condensation is usually the primary reason for mould growth on walls. Excessively humid air is likely to condense into water on cooler surfaces like walls when there is a fair temperature difference between indoors and outdoors. This condensation can foster mould growth. Moreover, further aggravation can result from other sources of water intrusion into the dwelling, including those caused by plumbing leaks, a broken roof, or seal failure around windows [30]. These sources become constant providers of water, which then enhances the progressive development of mould. Proper ventilation, maintenance of plumbing systems, and inspection and repair of possible points of entry for any kind of water intrusion are preventive measures against mould growth.

(f) Mould

As can be seen in Figure 2(c), effective cleaning of mould-affected areas requires one to prepare a solution of one part bleach to ten parts waters in the bucket. After soaking, proceed to apply the bleach solution liberally onto the surface affected by the mould and let it sit for a few minutes to enable the killing of the mould completely. Scrub the surfaces affected rigorously to ensure that any visible mould residue is removed. After scrubbing, the surface should be rinsed thoroughly with clean water to remove the bleach solution and any remaining mould particles. In this step, care should be taken to ensure that the cleaned surface is well-dried to avoid any residual moisture, which may provide substrates to nourish further mould growth. In a situation where the level of mould infestation is a huge, then professional remediation services can be sought for thorough and safe removal of the mould [20].

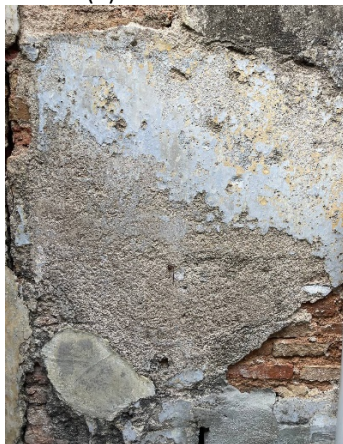
As visible in Figure 1 (g), honeycomb defects are characterized by the existence of voids or gaps that resemble the structure of a honeycomb and therefore compromise the integrity and strength of concrete. These defects usually result from several key problems during the construction process [6]. The first is flawed compaction, where inadequate pressure is applied to the mix, hence not being capable of completely filling the forms. Another critical factor is insufficient vibration while pouring,

which aids in removal of air pockets and ensures uniformity of mixture without which voids will be formed. Very significant also are the environmental conditions: these may reach very high temperatures that shall increase the rate at which not only the evaporation of water needed for proper curing takes place but also humidity variations, both, which will result in honeycombing. These defects decrease the structure capacity of concrete, its durability, and life; they also call for due attention during construction practices and environmental conditions to avoid creating them.

(g) Honeycombing

In honeycombed areas of concrete, first, all loose rubble and dust from the surface should be removed. The surface to be repaired is then to be cleaned using a stiff broom or compressed air to ensure that it is free from dust and particles. This step is done to enhance good anchorage of the repairing materials onto the concrete through mechanical bonding. By doing so, ensure a clean and debris-free surface where the repair materials will have good bonding to enhance the strength and durability of the set concrete [18].

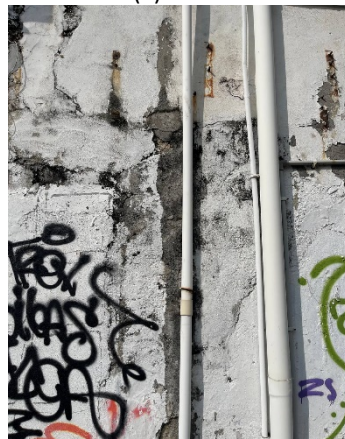
As illustrated in Figure 1 (h), This style of damage is reflective of a widespread graffiti culture wherein individuals deface public or private property with unauthorized markings or designs. This culture often crops up due to various socio-economic factors, like an unhappy urban environment, social alienation, and a desire for expression of self. The best way to deal with the situation is to understand the impulses and societal context that continue to perpetuate such behaviour. It is also, many a time, an intricate product of the interplay between these socio-economic factors, urban milieu, social alienation, and the urge for self-expression [31]. This multidimensionality of graffiti explains why it cannot simply be conceived of or looked at as an act of vandalism but is rather a carrier of deeper social issues and the urge for individual identity and visibility within a community. It will be imperative to understand and address these root causes, which contribute to strategies for mitigating graffiti use without necessarily pushing back on the positions and needs of those engaging in the graffiti.

(h) Vandalism

Security cameras are to be installed at some strategic points directly opposite a property on the upper floor to increase vigilance, which would hamper vandalism incidents. All vulnerable spots, entry points, and views from the cameras should be covering these areas. Lighting conditions should also be optimally bright, particularly in dimly lit areas. Bright light is considered one of the potent deterrents to unwanted activities. Consider the inclusion of motion-activated lights that turn on immediately upon the detection of movement. The sudden illumination works as an excellent deterrent for vandals by reducing the possibilities of acts of vandalism tremendously [17].

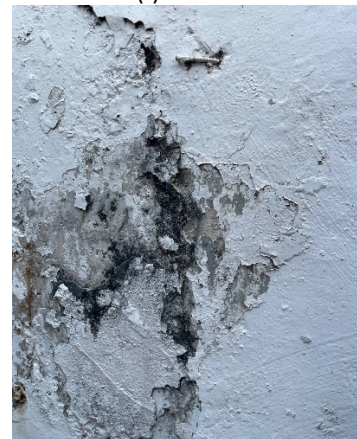
As can be found in Figure 1 (i), leakages from broken roofs and burst pipes, as well as faulty seals of window frames allowing water into the walls, are the main reasons for water infiltration into the building. Poor ventilation reinforces this process by preventing the moist air from being released to the outside atmosphere, where it will evaporate, thus leading to perpetual dampness [32]. These conditions certainly contribute greatly to mould proliferation, structural damage, and deterioration of indoor air quality. An effective solution will have to involve not only the sealing of leak sources but also enhancing ventilation to let moisture that can infiltrate into the building evaporate efficiently and outgas it to keep it dry and healthy indoors.

(i) Dampness

Damp-proof membranes and coatings applied to walls prevent dampness in buildings. According to Nikmat and Sabihah [20], damp-proof membranes are largely used in both new buildings and refurbishment processes for preventing the ingress of moisture and its consequences, such as mould growth, degradation of building materials, and structural damage." These membranes are normally applied at construction time to prevent water infiltration into a building element. On the other hand, damp-proof coatings act as retrofitting to virgin walls and significantly reduce dampness by creating a repellent for water/moisture. All these damp-proofing solutions, when properly applied and adhering to the manufacturer's specifications, assure enduring protection and, therefore, enhance the life span of the building structure.

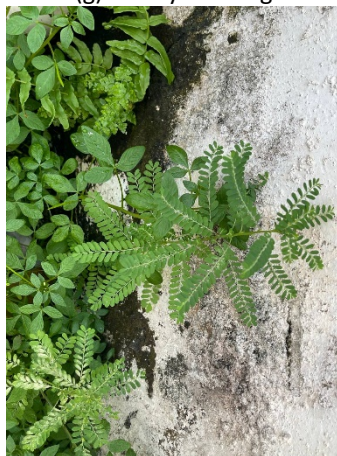
Figure 1(j) shows the cracks that occurred at the wall. Encroachment of vegetation refers to the growing of plants or weeds on or around surfaces of walls. Often enough, this is abetted by factors such as sunlight exposure and amounts of humidity that create a conducive environment for the growth of plants [33]. Eventually, this growth leads the roots to enter the cracks of the walls and develop physical damage, thus impairing their structural integrity. It may also serve to retain some moisture against the wall, just perfect for further decay and thereby weaken the structure. Addressing vegetation encroachment, therefore lays in the form of regular maintenance, wherein after scraping off the plants and repairing the cracks an inclusion of managing the environmental factors that led to the growth in the first place is made. This will ensure surface protection against the building from external factors is retained for as long as needed.

(j) Vegetation Encroachment

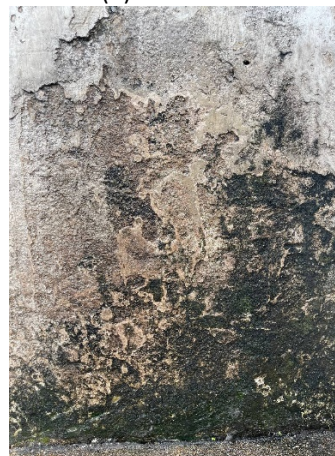
As can be seen in Figure 1(k), Fungus growth on walls is greatly influenced by a set of factors that combine to provide a friendly environment for the proliferation of fungi. High levels of moisture are chief among these and are usually due to pipe, roof, or window leakage that allows intruding water to stay within the walls [32]. Such wet environments are ideal for fungi to grow and breed since fungus germinates and grows only in a moist environment. Once established, the fungi will further perpetuate the problem of moisture by retaining both water and nutrients, hence creating an environment that will create serious damage, such as decaying organic materials or degrading wall surfaces. This can be achieved by stopping the ingress of moisture at its source and curing it through improved ventilation, although fungicidal treatments will likely be required to prevent re-growth and protect the building structure.

(k) Fungus

There are two major methods to control moisture indoors: improving ventilation and using a dehumidifier. Improved ventilation keeps the air moving in a building and will, therefore, more quickly lower humidity by removing moist air and exchanging this with relatively drier air. Simple practices such as opening windows when the weather allows, running exhaust fans in kitchens and bathrooms, and keeping air vents clear are beneficial for promoting indoor circulation of air and reducing humidity inside building [18]. Moreover, the dehumidifiers could deal with the excessive humidity in those places and ensure ideal moisture levels are attained, therefore eliminating problems like the growth of moulds and structural problems brought about by excess humidity inside.

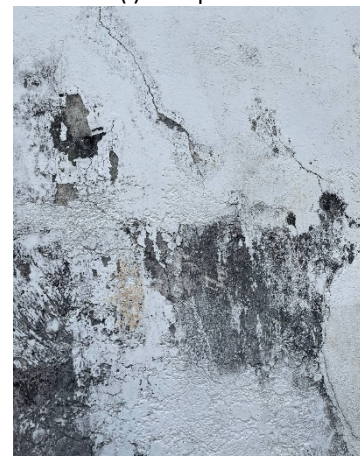
Figure 1(l) shows the cracks that occurred at the wall. Cracks in walls are mostly the result of natural aging and wear over time. Various factors act together to bring about this kind of worn state of a building. Environmental exposure to sun, wind, and moisture makes most of the materials weak. Other factors include structural stress during the settlement or movement of buildings, while others could be from regular use and vibrations that cause the formation of cracks in them [34]. These cracks may start small but later begin to widen, making the wall vulnerable to infiltrations of water into the wall and thus causing deterioration. This may be the source of other problems related to structures in buildings. It is, therefore, the only way to ensure the durability and safety of the buildings by inspecting them regularly for cracks and repairing them at the most opportune time, fixing the problem before it leads to higher structural problems.

(l) Cracks

In cases where the crisis is too weak regarding the structure of the building, epoxy injection is advocated as the best treatment for effective repair. It reopens the crack back to its original condition with the use of high-strength epoxy resin, which adheres well with concrete to achieve strong attachment. Not only does this assist in stabilizing the structure, but it also prevents recurrence or further expansion of the crack. Under pressure, the epoxy resin is injected into the crack so that all the void space is filled and tightly attached to the surrounding concrete [21]. At this point, curing the epoxy thereafter fully reinstates the structural integrity of the concrete, thereby leaving the area perfect and strong. In such a manner, it becomes particularly effective for addressing structural cracks when long-term stability and safety are paramount to a building

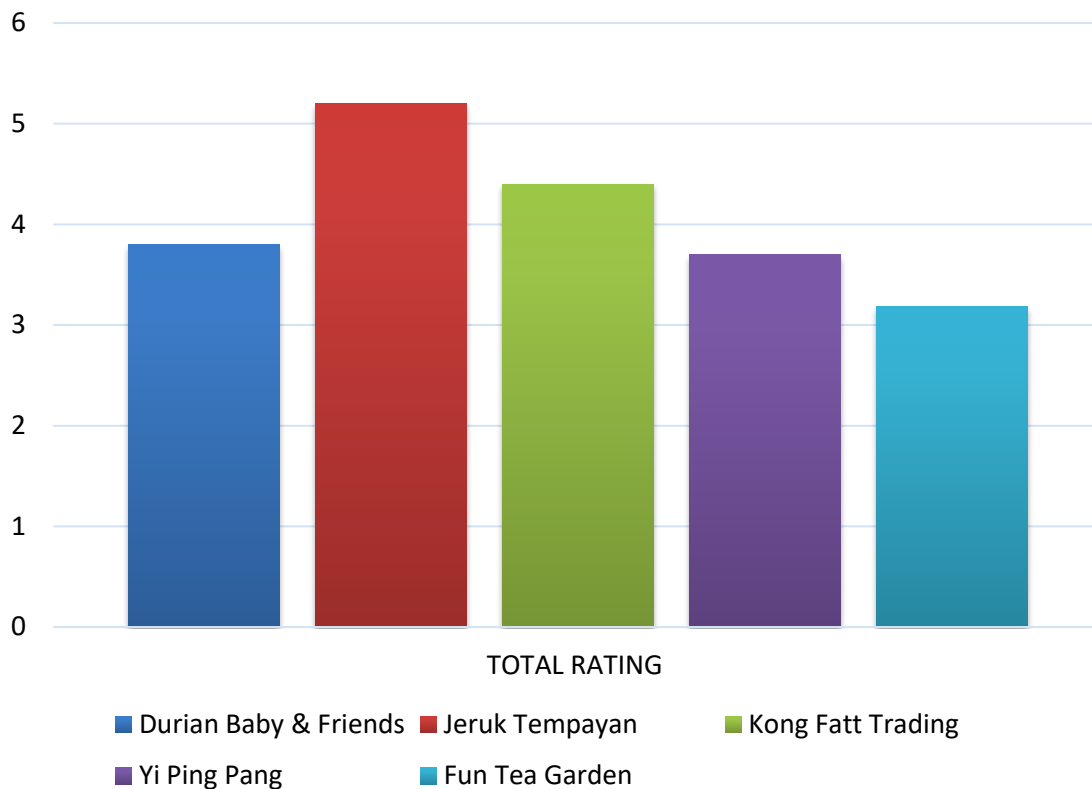
Fig. 3. Building rating

Based on the Figure 3, ratings for five buildings may be based on their overall scores. Jeruk Tempayan scores highest with 5.2, meaning it attains the highest rating among the five case studies. Next in rank is Kong Fatt Trading with a total score of 4.4. Following this is Yi Ping Fang, attaining a total score of 3.7. The worst-rated building among the case studies is the Fun Tea Garden, with a total score of 3.18; this ranking, therefore, gives a view of their condition and performance according to the criteria measured in the evaluation process.

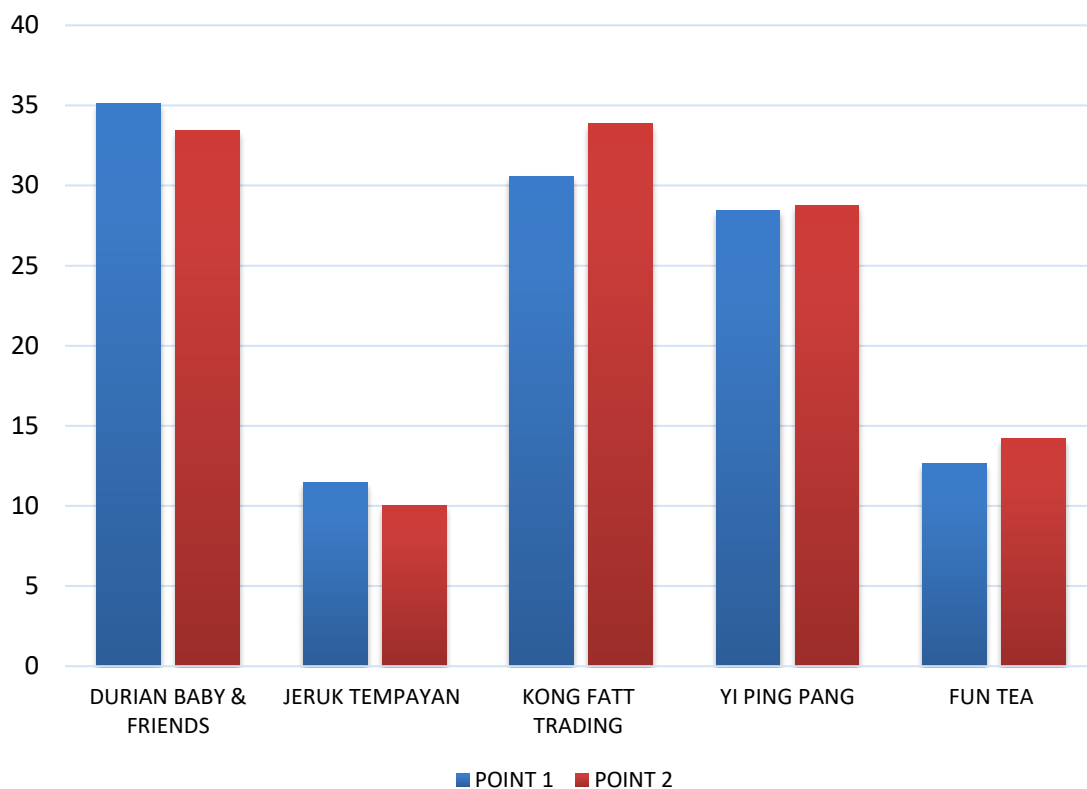
Fig. 4. Overall result of rebound hammer

Based on Figure 4, Durian Baby & Friends and Kong Fatt Trading both have very consistent quality concrete throughout their tested points on the wall, with an average rebound number of 30.55 to 35.11. This probably is because the buildings use well-mixed and rightly cured concrete; hence, they enjoy a high rating for structural integrity. In contrast, Jeruk Tempayan, Ying Ping Yang, and Fun Tea Garden show poor quality concrete for their respective wall sections. Where mean rebound values were 10 to 14.22, both showed exceptionally low averages, indicating the presence of unsatisfactory concrete quality and in the end bringing down the structural strength and durability of the building. The wall points of Ying Ping Yang indicated fair-quality concrete, with a rebound number of 28.44 to 28.77. That means improvement may be needed, but not as serious as the other two.

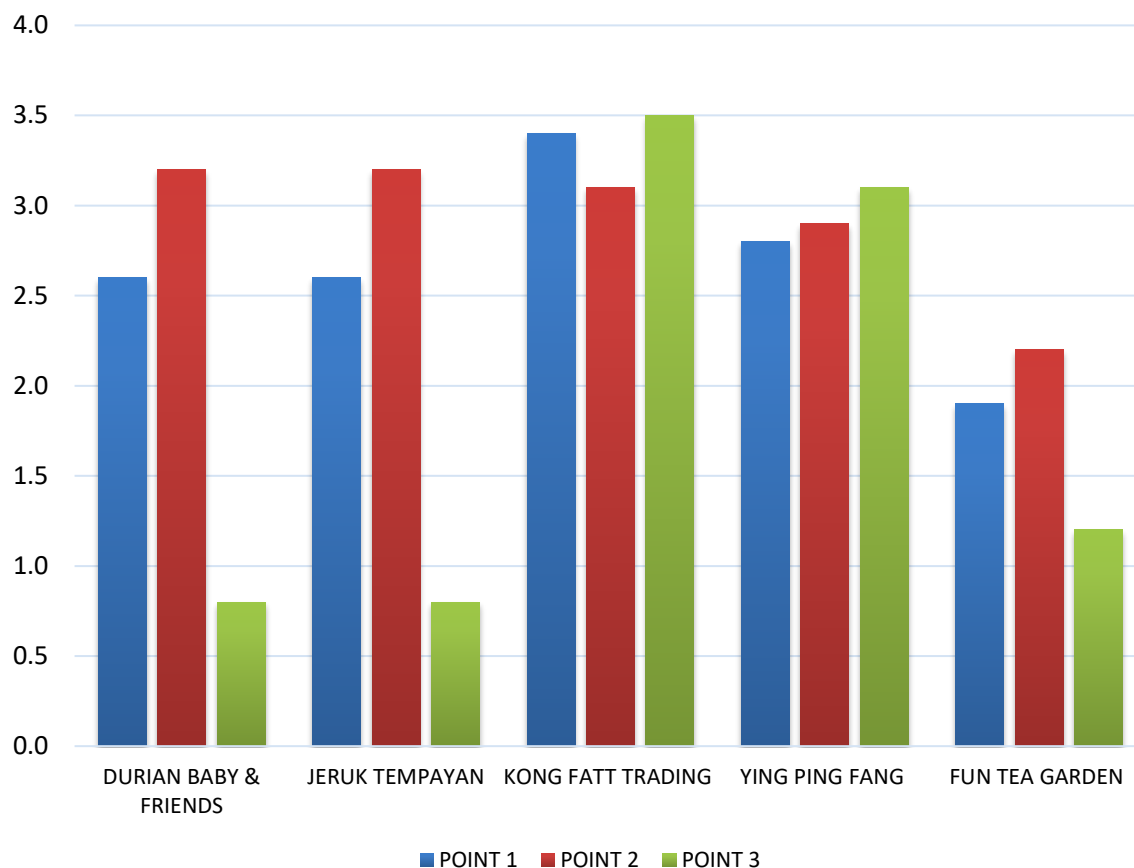
Fig. 5. Overall result of moisture test

Based on Figure 5, Jeruk Tempayan measured 3.0%, 3.1%, and 3.6% at points 1, 2, and 3, respectively. The results from Kong Fatt Trading showed 3.4%, 3.1%, and 3.5% at their respective points 1, 2, and 3. At Ying Ping Yang, the respective readings were 2.8%, 2.9%, and 3.1%. Finally, Fun Tea Garden recorded the lowest levels at 1.9%, 2.2%, and 1.2% measured during points 1, 2, and 3, respectively. The Moisture Content levels were relatively flat across all structures tested, thus indicating a low-to-moderate degree of moisture availability within the considered walls. It is thus deduced that although it may be high in some spots and requires attention, at most other places, it is within acceptable limits. Continuous monitoring and maintenance will indeed keep the moisture controlled and lead to no further damage concerning the structure's integrity over time.
