Failure Analysis of Valve Unit for MAN 9L21/31 Diesel Engine Generator

Wilarso^{1,2,*}, Che Wan Mohd Noor¹, Ahmad Faisal Ayob¹, Wan Nurdiyana Wan Mansor¹, Muhamad Ali Pahmi^{1,2}

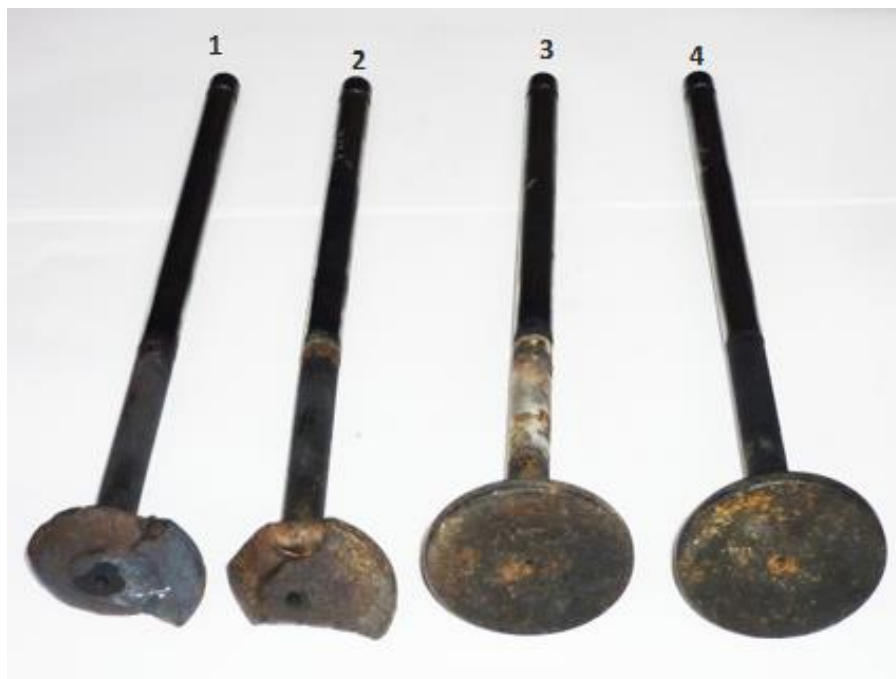
Fig. 2. Close-up image of the valve

Figure 2 compares macro pictures of exhaust valves 1 and 2 with damaged gutters to gutters in good condition to validate the investigation of the causes of damage. Intake valves 3 and 4 are in good working order.

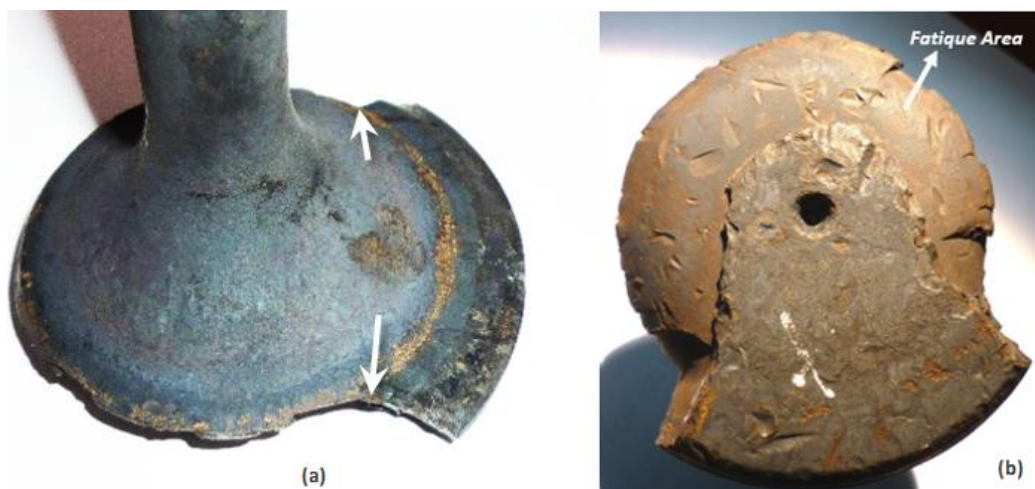
Fig. 3. Test valve

Figure 3 depicts a stress fractured test valve with damage or gutters on the valve head. The shape of the fatigue fracture area is included in the material of the valve base, which goes through a forging process to make the core region more structurally homogeneous and avoid fracture. Figure 3(a) and Figure 3(b) show the upper surface of the valve stripped. Figure 3(b) shows that the guttering is caused by high-temperature gas escapes between the valve face and valve cushion. This leak is caused by foreign particles lodged between the valve face and the valve cushion.

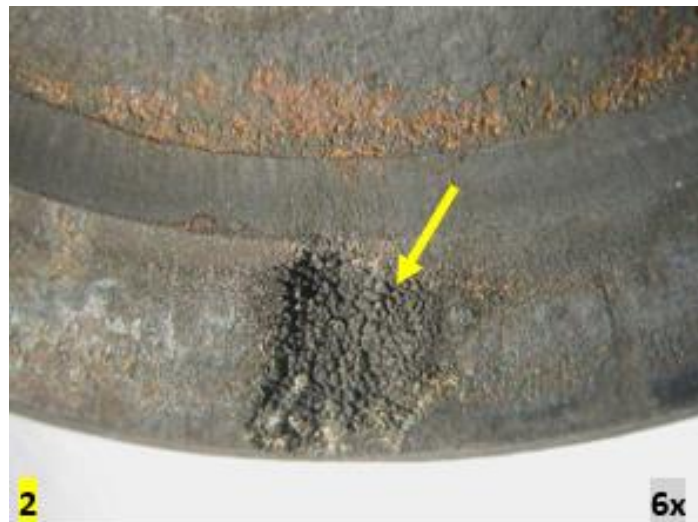
Fig. 4. On the valve seat, carbon

Figure 4 shows that the initial fracture is assumed to have been caused by an insufficient combustion process, which resulted in the accumulation of fuel scale or deposit on the component in contact with the engine body, resulting in combustion detonation. Meanwhile, the detonation of combustion shocks and stresses the valve head.

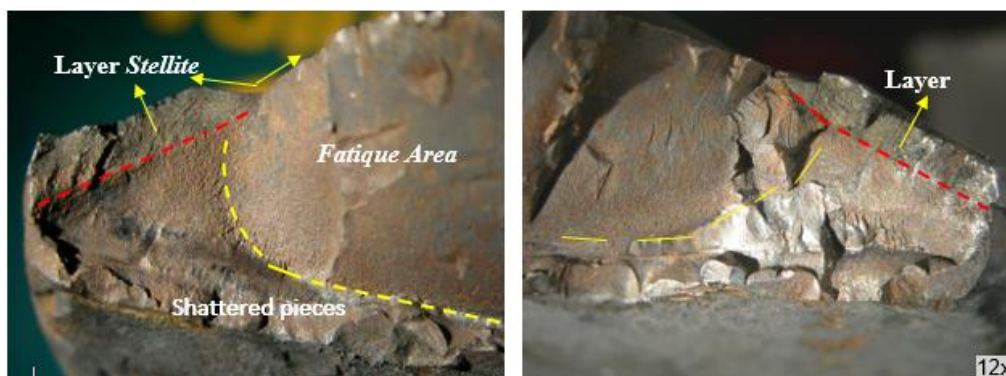
Fig. 5. Components of the valve are shown in a micrograph

Figure 5 depicts the angle formed by the valve head's base material and the stellite layer, which is a high-stress area where combustion deposits can easily collect.

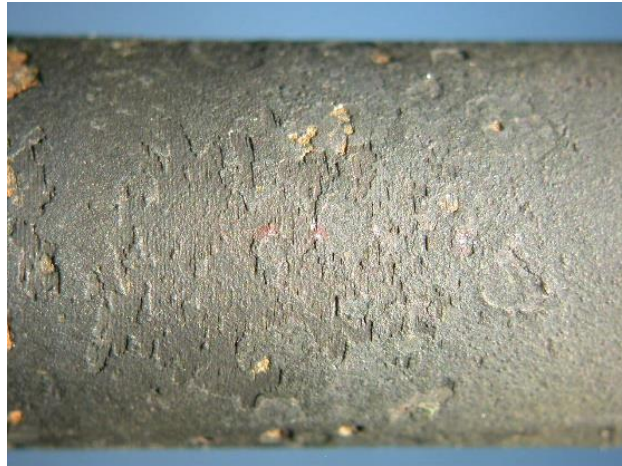
Fig. 6. Valve stem

Figure 6 depicts an accumulation of deposits on the valve stem induced by incomplete combustion (traces of deposit buildup or crust that has fallen off).

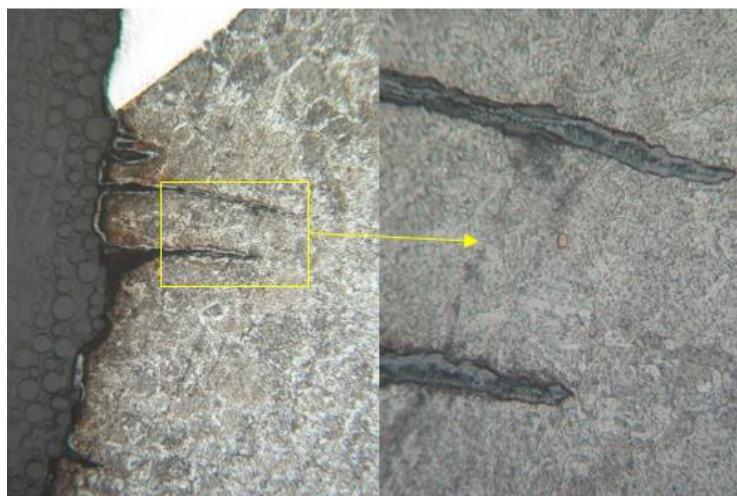
Fig. 7. Valve microstructure

Microstructure thermal fatigue corrosion occurs where the valve material area and stellite material meet in Figure 7. At the fracture's conclusion, a deposit product with symptoms of a high-temperature corrosion attack has formed. The stellite layer suffers from the same high-temperature corrosion as the valve base material does; however, this time, a combustion explosion is to blame, and the result is the same. The stellite layer is normally 2.1 mm thick and 10 mm wide, but when eroded, it is 17 mm thick.

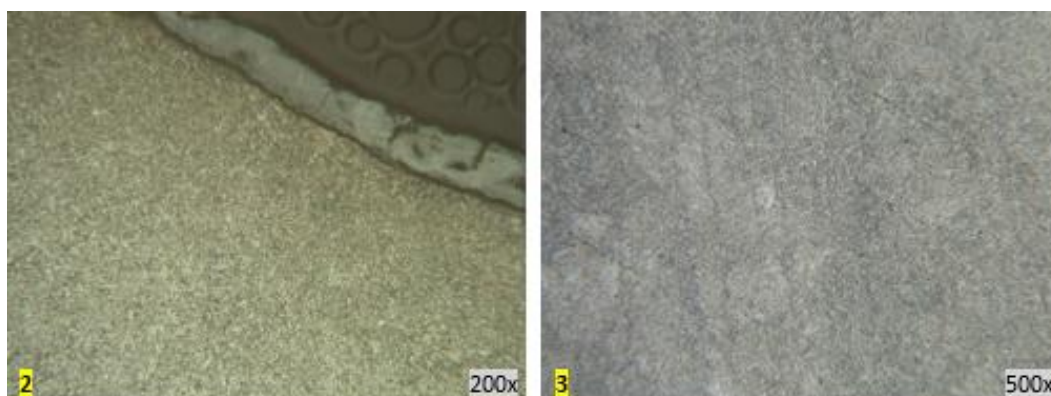
Fig. 8. The stellite material's microstructure

The microstructure of the stellite material in Figure 8 is made up of austenite dendrites, and thermal fatigue corrosion occurs. The valve head material has a bainite microstructure with fine carbide grains that are uniformly dispersed.

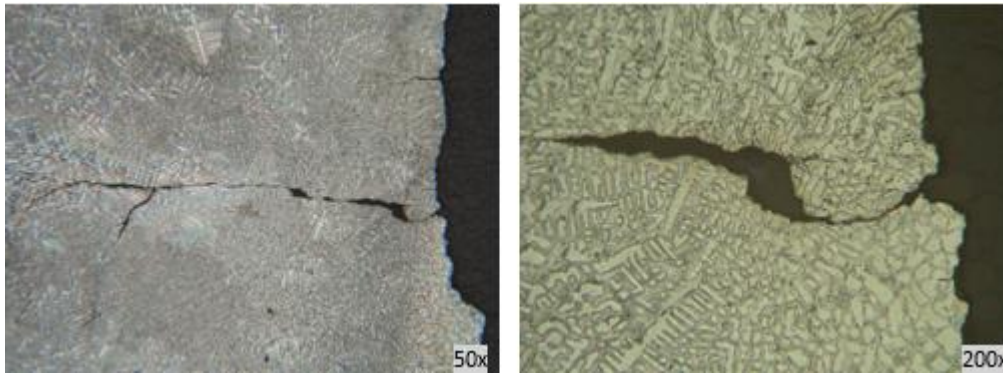
Fig. 9. The basic material for the valve's microstructure

Thermal fatigue corrosion cracks are observed from the thick side in Figure 9. The microstructure of the valve base material is bainite-ferrite, with tiny carbide grains dispersed uniformly throughout. Thermal fatigue corrosion appears as austenite dendrites in the stellite microstructure.

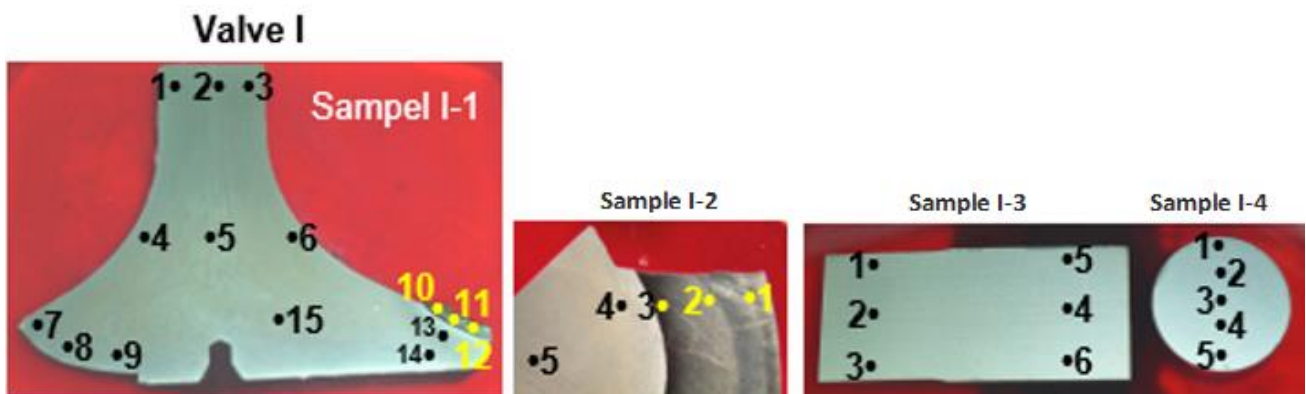
Fig. 10. Measure for hardness position

Figure 10 shows the position of the hardness test, which used three test samples. Material hardness tests on Samples I-1 Numbers 10 (507 HV), 11 (507 HV), and 12 (523 HV), as well as Samples I-2 Numbers 1 (558 HV) and 2, (523 HV), show this. High voltage arc welding is used to form a hard surface on the surface of the valve from nickel, chromium, and molybdenum alloy steel [12].

Table 1 demonstrates that the material's hardness weakens progressively beginning with valve I in this hardness test. This implies that the hardness of the valve will decrease as its useful life grows. Because the material became brittle due to the elevated temperature, samples I-1 numbers 7, 8, and 9 on the valve head exhibit decreased hardness.
