Application of UAV and CSPI Matrix for Roof Inspection at Dewan Sultan Ibrahim and Dewan Tunku Mahkota Ismail UTHM

Nor Baizura Hamid¹, Masiri Kaamin^{1,*}, Noorul Hudai Abdullah¹, Mardiha Mokhtar¹, Siti Nooraini Mohd Razali¹, Muhammad Naim Abu Bakar¹, Mohamad Ridhwan Zahri¹, Nur Thaqifah Aina Mohd Zaidi¹

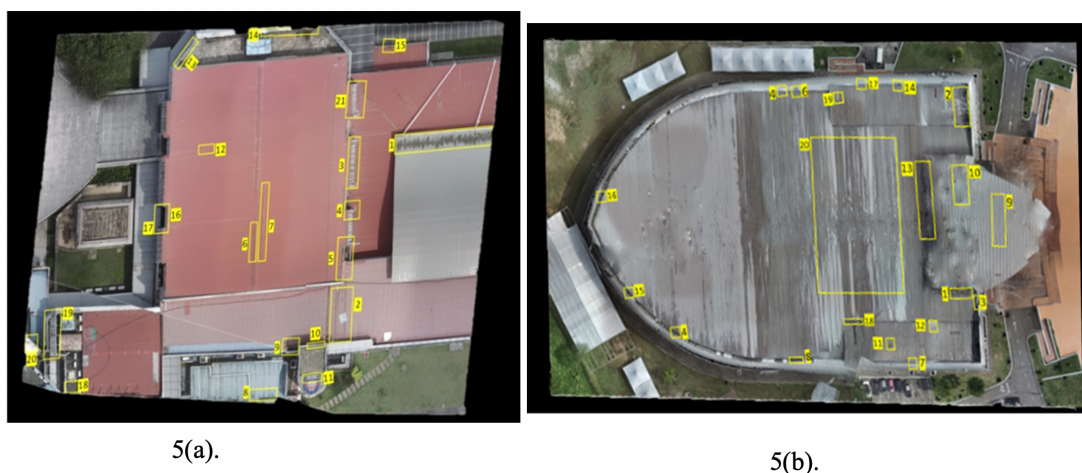
Fig. 5. (a) and (b). Full view of DSI and DTMI with the location of the defect

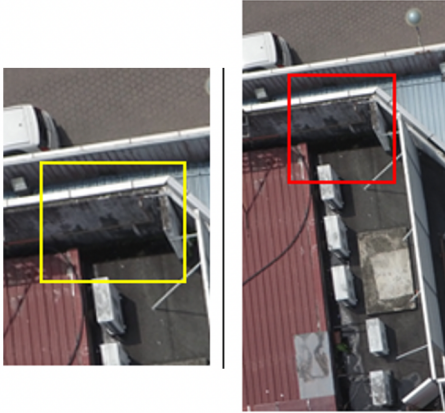
Details	Picture								
No. of defects = 15 <table border="1"> <thead> <tr> <th>Condition</th> <th>Priority</th> <th>Matrixs</th> <th>Color</th> </tr> </thead> <tbody> <tr> <td>2</td> <td>1</td> <td>2</td> <td style="background-color: green;"></td> </tr> </tbody> </table> Element/components: EL/CS 28: Others Defect Details: DS/CS 20: Algae Growth Required Action: Cleaning up the algae	Condition	Priority	Matrixs	Color	2	1	2

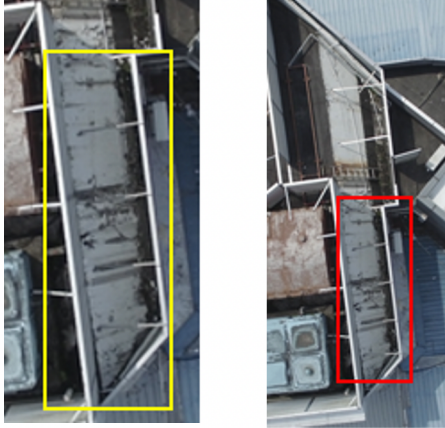
Condition	Priority	Matrixs	Color						
2	1	2							
No. of defects = 16 <table border="1"> <thead> <tr> <th>Condition</th> <th>Priority</th> <th>Matrixs</th> <th>Color</th> </tr> </thead> <tbody> <tr> <td>3</td> <td>3</td> <td>9</td> <td style="background-color: yellow;"></td> </tr> </tbody> </table> Element/components: EL/CS 28: Others Defect Details: DS/CS 08: Defect Required Action: Fix it up	Condition	Priority	Matrixs	Color	3	3	9

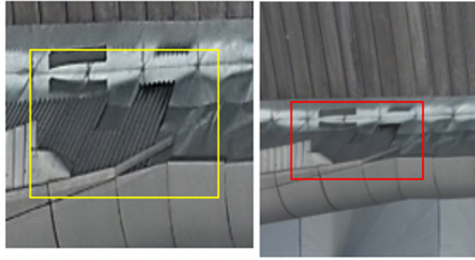
Details				Picture									
No. of defects = 6 <table border="1"> <thead> <tr> <th>Condition</th> <th>Priority</th> <th>Matrixs</th> <th>Color</th> </tr> </thead> <tbody> <tr> <td>2</td> <td>2</td> <td>4</td> <td style="background-color: green;"></td> </tr> </tbody> </table> Element/components: EL/CS 15: Roof Defect Details: DS/CS 20: Damage Required Action: Maintenance works				Condition	Priority	Matrixs	Color	2	2	4

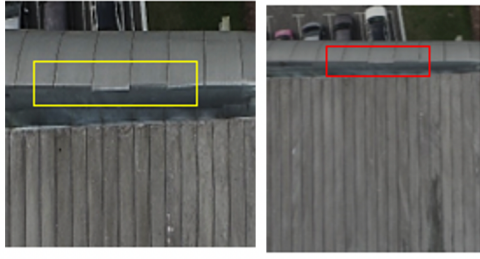
Condition	Priority	Matrixs	Color										
2	2	4											
No. of defects = 7 <table border="1"> <thead> <tr> <th>Condition</th> <th>Priority</th> <th>Matrixs</th> <th>Color</th> </tr> </thead> <tbody> <tr> <td>1</td> <td>2</td> <td>2</td> <td style="background-color: green;"></td> </tr> </tbody> </table> Element/components: EL/CS 15: Roof Defect Details: DS/CS 08: Unneat Required Action: Maintenance works				Condition	Priority	Matrixs	Color	1	2	2
