Exploration of Timber Dry and Wet Rot Defects in Buildings: Types, Causes, Effects and Mitigation Methods

Rozaidi Arsyad Mahalil¹, Md Azree Othuman Mydin^{1,*}, Roshartini Omar^{2,3}

Structural defects; non-structural defects; timber buildings; dry and wet rot; timber elements

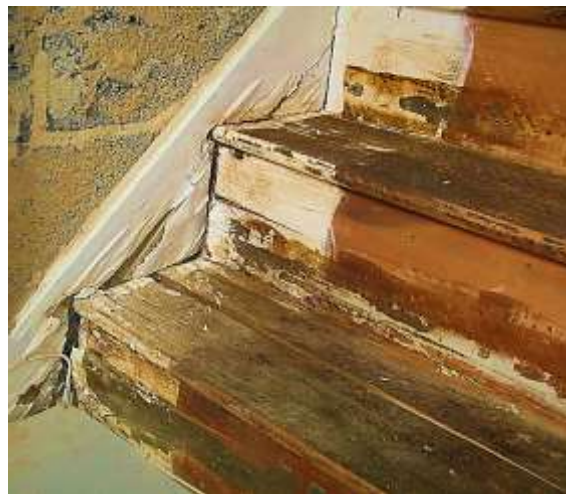
Fig. 1. Timber decay occurs at the staircase

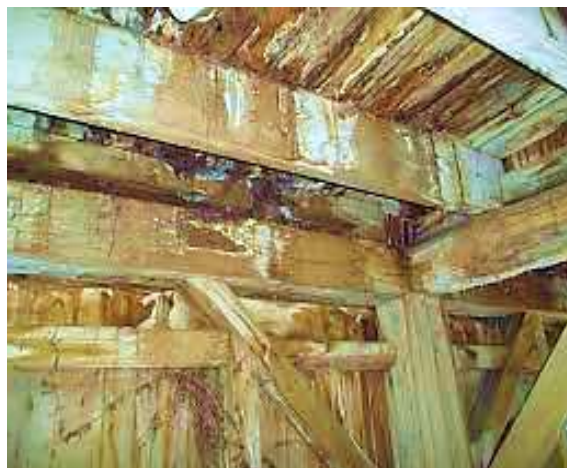
Fig. 2. Serious deterioration of structural timber

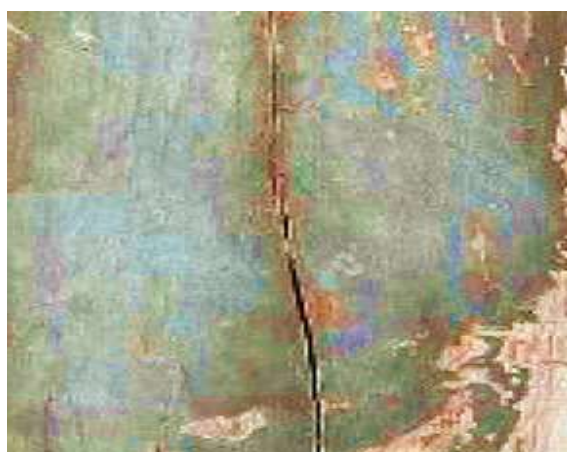
Fig. 3. Visible cracks on timber structure

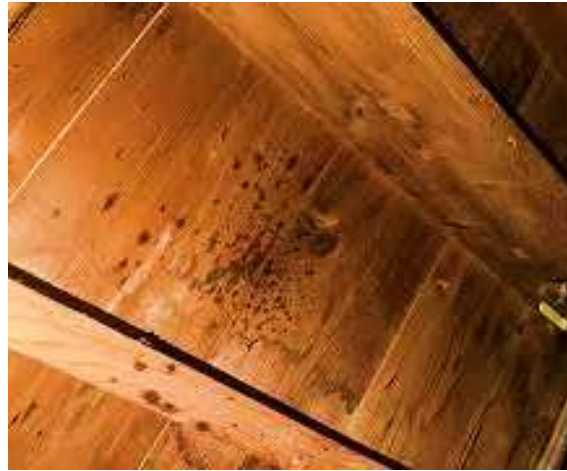
Fig. 4. Visible cracks on timber structure

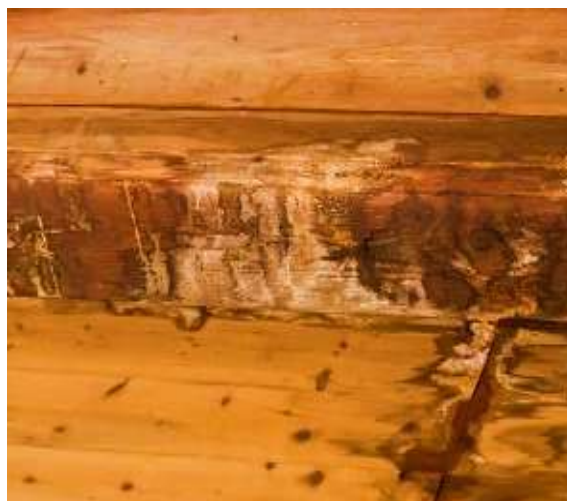
Fig. 5. Dampness problem on structural timber

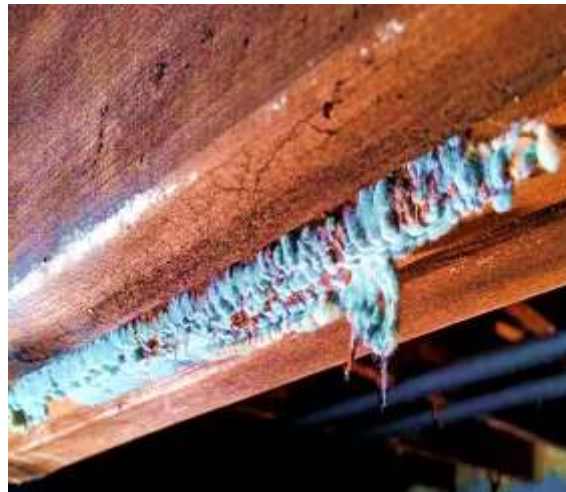
Fig. 6. Mould growth at timber structural beam

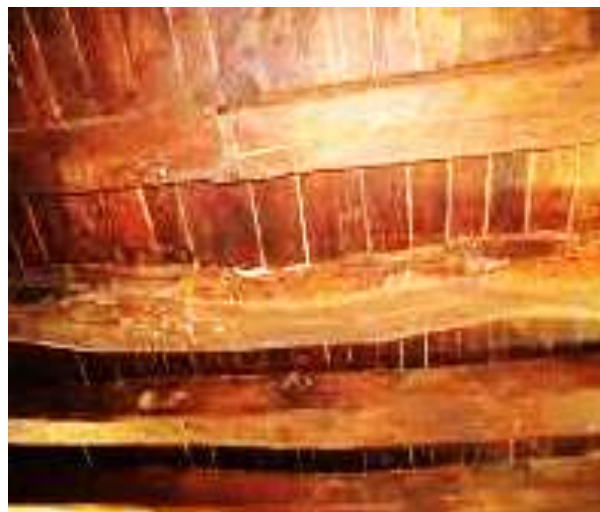
Fig. 7. Timber brittleness in the floor joist's section

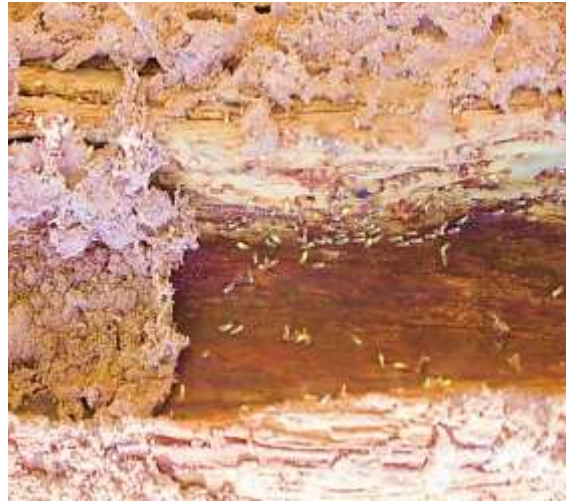
evidence of terminate attack on the timber flooring of a structure. Frequently, termites can be seen inside timber structures, where they create a thin protective layer to shield themselves from the external surroundings. The implementation of chemical and mechanical barriers will effectively deter soil termites from infiltrating the building. However, it should be noted that these measures will not provide protection against dry termites, as they can fly and are not hindered by such barriers.

Fig. 8. Terminate attack on the timber flooring of a structure
