Effect of Post Heat Treatment to High Temperature Hydrogen Attack (HTHA) Corrosion of Decarburised Carbon Steel

Azzura Ismail^{1,*}, Amin Ali¹

¹ Faculty of Mechanical and Manufacturing Engineering, Universiti Tun Hussein Onn Malaysia, Batu Pahat, Johor, Malaysia

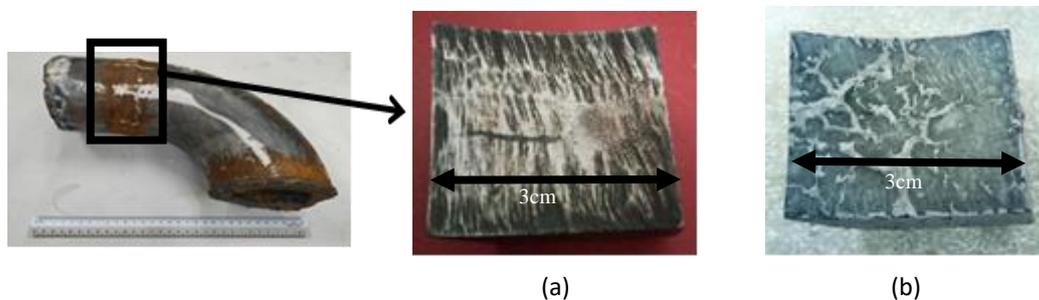
For visual analysis, after the carbon steel has been cut through Oxy-acetylene Torch cutting and Wire-cut EDM cutting, it is clearly seen that there are cracks presence on the inner surface of the carbon steel. Indeed, the cracks formed are caused by the hydrogen attack. When this carbon steel pipe is cut, it has a concave surface and not a flat surface. Figure 2(a) showed the carbon steel pipe

that already undergoes failure due to hydrogen attack which has been cut by Oxy-acetylene Torch cutting and Wire-cut EDM cutting on the welding area (high stress area).

Heat treatment is done on the specimen to observe the reduction of crack length after undergoing heat treatment. Heat treatment is done at a temperature of 900°C with a holding time of seven hours. As for the crack length of the specimen before undergoing heat treatment, the length is for about 13 mm. The crack length of the specimen is reduced to 9 mm after undergoing heat treatment with a total crack reduction of 30.77%. It is observed that after the specimen undergo heat treatment, the carbon steel tends to create the oxide layer. The oxide layer is a corrosion product that protects carbon steel from the reaction with the environment. It is observed that the oxide layer has a fragile characteristic where the fragile characteristic that came from the situation of the oxide layer can be removed easily. The oxide layer becomes fragile due to some cracks that happen to appear on the oxide layer surface, hence the adhesion between the substrate (carbon steel) to be protected and the oxide layer becoming less effective. The crack on the oxide layer may due to stresses that applied on the surface (externally) and the stress from the inside (internally). Moreover, the surface of the carbon steel is not flat and it is in a concave surface that it will influence the adhesion of the oxide layer with the substrate to become less effective. Figure 6(e) shows the piece of the oxide layer from the carbon steel. After removing the oxide layer, the crack length after undergoes heat treatment was observed. When removing the oxide layer, the crack length is seen but not very clear due to the primer oxide layer (black colour) on the specimen surface, but the crack length can still be seen through visual inspection. Figure 2 showed the comparison result of before and after heat treatment is done on the specimen with the oxide layer is formed on the specimen surface.

Fig. 2. Crack on the surface of carbon steel (a) before and (b) after heat treatment

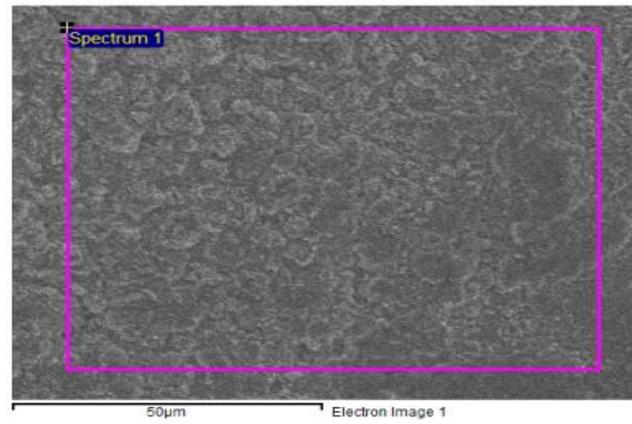
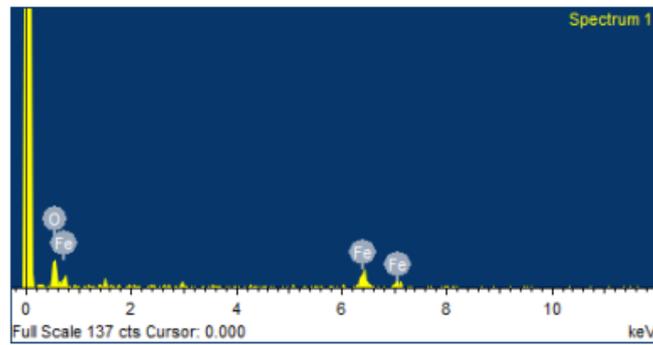
Furthermore, as for the confirmation of the oxide layer formed on the surface of carbon steel, a further test is conducted. EDX result as shown in Figure 3, revealed the oxide layer formed on the surface of carbon steel, covering the overall surface of carbon steel. From the EDX test on the oxide layer, only the element of iron (68.69%) and oxygen (31.31%) that existed on the oxide layer. These elements contribute to the formation of a protective layer of carbon steel. Moreover, the XRD test is conducted on the oxide layer of carbon steel. XRD has revealed the formation of oxide layers on failed carbon steel. The oxide layer present is hematite (light green), magnetite (blue) and wustite (light purple). Hematite, magnetite, and wustite are all forms of iron oxide that present on the oxide layer of carbon steel. The purpose of this corrosion product formed on the carbon steel is to protect the substrate which is the carbon steel from reacting with the environment and become a passive metal that resists to corrosion.

Fig. 3. EDX result on the oxide layer

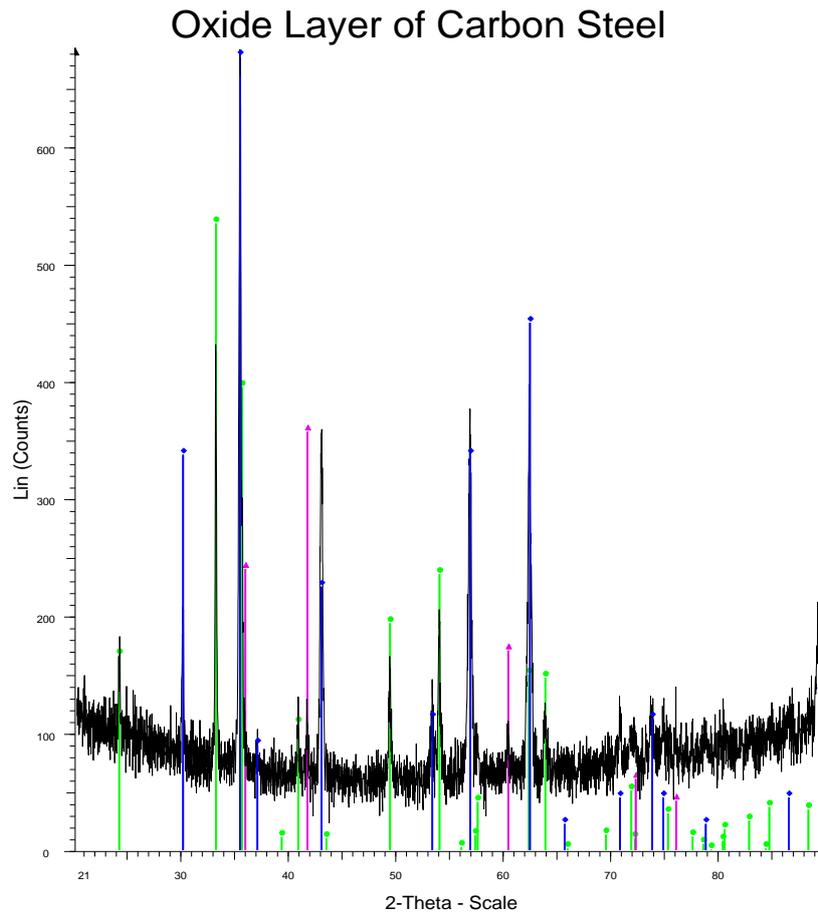
Fig. 4. XRD result on the oxide layer

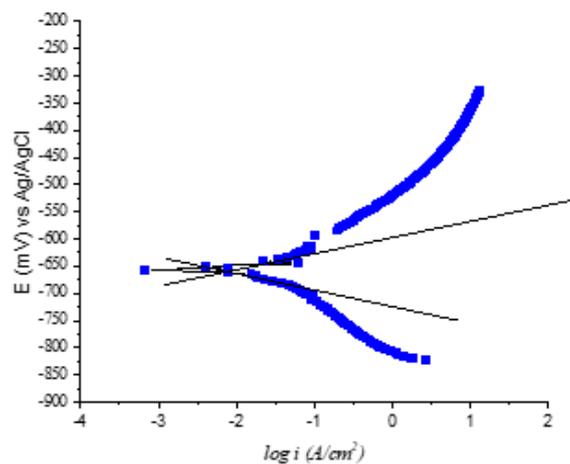
Electrochemical test enables the corrosion behaviour to be monitored over a wide range of oxidizing conditions in a single environment [13]. For potentiostat device, the scan rate used was 2mV/sec where the area of the specimen was 8cm². The value of corrosion current density (I_{corr}), corrosion potential (E_{corr}), open circuit potential (OCP) and corrosion rate (CR) were obtained. Tafel plot as shown in Figure 5 gives the values 17.974 μ A, -656.783 mV and - 656.9 mV for I_{corr} , E_{corr} , OCP respectively. The corrosion rate was then calculated and the value is 26.081 mm/year. Quite a high rate due to oxidation reaction to give oxide layer for protection purposes.

Fig. 5. Tafel plot

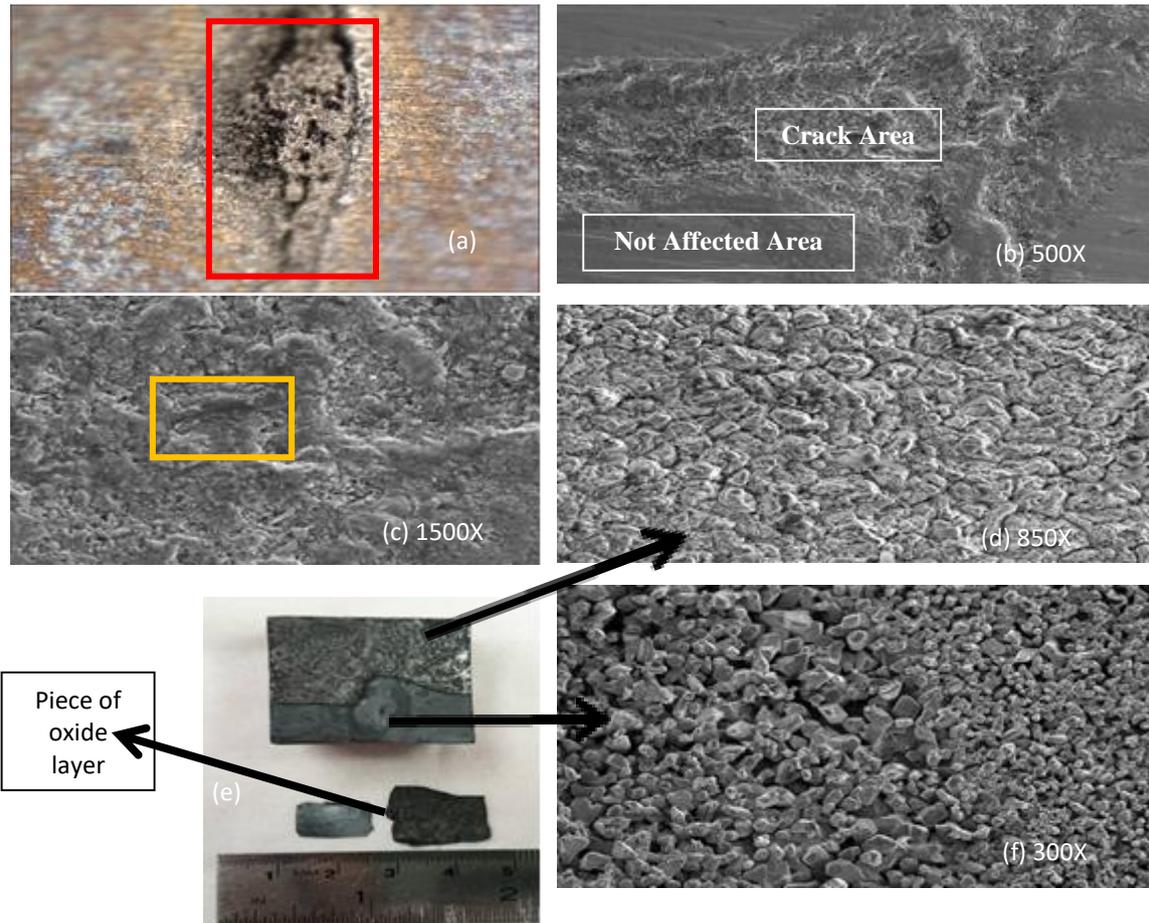
The images of the crack were obtained by observing the crack under the optical microscope. The crack on the carbon steel specimen was caused by the formation of methane gas (CH_4), results reaction of hydrogen with carbon in the steel. As the temperature and pressure increase, the methane gas that did not escape has caused cracks on the wall of the carbon steel pipe (High Temperature Hydrogen Attack). Hence, Figure 6 below showed the crack that was contributed by the methane gas. The crack image (red box) that was observed under an optical microscope is 10x magnification.

SEM result on the metallography was done before the specimen which is the carbon steel undergo heat treatment and also after undergoing heat treatment. Figure 6(d) shows the oxide layer surface while Figure 6(f) shows the surface of the carbon steel after the oxide layer is removed. Figure 6(c) shows the crack surface image observed by SEM that showing intergranular cracks of corrosion. Moreover, decarburization occurs where carbon steel loses the amount of carbon. It can be seen in Figure 6(b). The difference between the crack area and the not affected area showed that decarburization has occurred to the carbon steel that has been subjected to HTHA. Decarburization is damaging to the wear life and fatigue life of heat-treated components which cause poor wear resistance as well as low fatigue life [14]. Figure 6(e) shows the carbon steel surface of with and without oxide layer.

After the specimen undergoes heat treatment, the specimen is observed once again through the SEM test. From observation, carbon steel creates a passive film or oxide layer after undergoing heat treatment. The carbon steel is fully covered by the oxide layer. Through the SEM test, the observation on the carbon steel surface's specimen is done with the oxide layer and without the oxide layer. From Figure 6(f), the surface was with no oxide layer and it was observed that the structure is denser. The white granules seem to appear in numbers on the surface without an oxide layer. The oxide layer formed on carbon steel was easily removed, hence it is a fragile oxide layer. Besides, it was observed that the structure of the oxide layer is like a crystalline structure (Figure 6(d)).

Fig. 6. Crack on carbon steel at different magnification and oxide layers (right bottom)
