Analysis of High Vibration Causing 211-P-25A Centrifugal Pump Damage in Hydrocracker Process

High Vibration; Internal Recirculation;
Cavitation; Centrifugal Pump

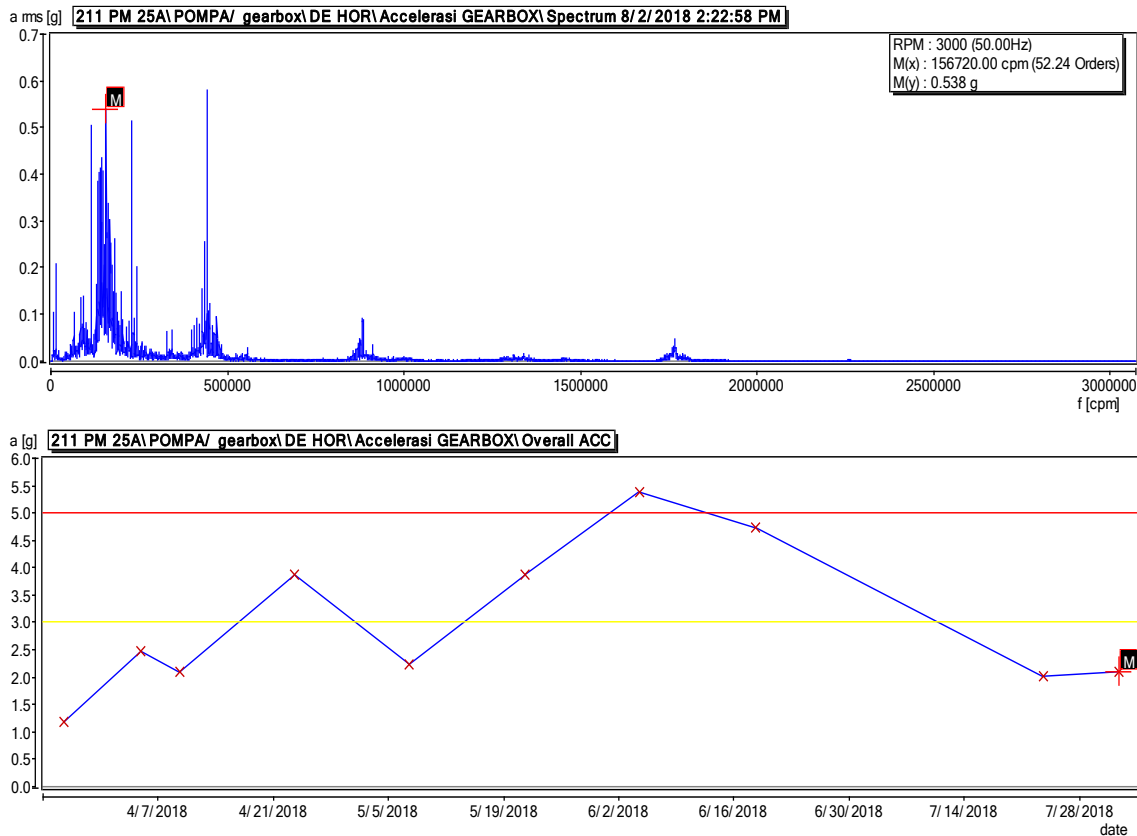
Fig. 2. Vibration measurement curve 211-P-25A [10]

Based on Table 4 in the box, it was found that there was an increase in vibration during the 3GR DE H-ACC acceleration. From the unachieved flow produced by the pump, will increase the vibration, from this increase in vibration will damage other components [11]. Figure 2 shows the vibration measurement curve and the vibrational increase spectrum.

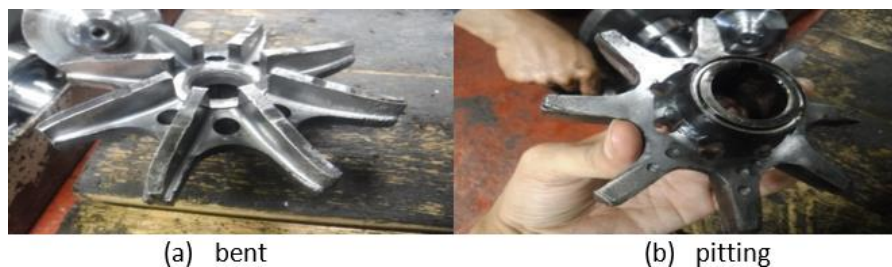
Fig. 4. (a) Bent and (b) pitting on centrifugal pump impeller 211-P-25A [10]

As a result of the internal recirculation effect, an inspection was conducted in the workshop area of Refinery Unit. It was found that the impeller on the 211-P-25A pump was pitting and bent. And there is also a scratch on the high-speed shaft gearbox.

Damage to the impeller is due to erosion of the impeller blade, causing damage to the impeller due to repeated internal circulation effects so that the impeller subjected to pitting and bent conditions. This effect causes the impeller to become unbalanced, which will affect the damage to other components. The impeller in the 211-P-25A pump serves to provide velocity energy to the fluid. The internal recirculation effect produces air bubbles, which then burst. If operated for a long time, there will be damage to the surface of the channel wall. The duct wall's surface will be potholes due to cavitation erosion as collisions of bubbles that break on the wall continuously. This is what causes the impeller subjected to pitting. Bent occurs because the impeller is continually experiencing the effects of internal recirculation and deforming the impeller blade. Internal circulation results in a decrease in pump engine performance. Internal circulation tends to occur in a low average flow rate and when fluid leaves the impeller by forming a vortex [11]. Figure 4 shows the bent and pitting of the pump impeller 211-P-25A

To eliminate low flow, additional flow can be done by fully opening the line bypass control. Then, if the flow requirement is above the minimum flow, additional flow is done manually by closing the line spill back after the maximum flow control FC-522 is no longer achieved [18]. Furthermore, the addition of instruments to the 211-V-23 vessel with auto stop with a minimum suction head of 3.5 m according to the pump NPSHr [19]. To increase pump efficiency, it can re-rate the pump impeller according to operational needs. This can be done with affinity law, to be able to change the flow and still maintain pressure to the system from the pump.

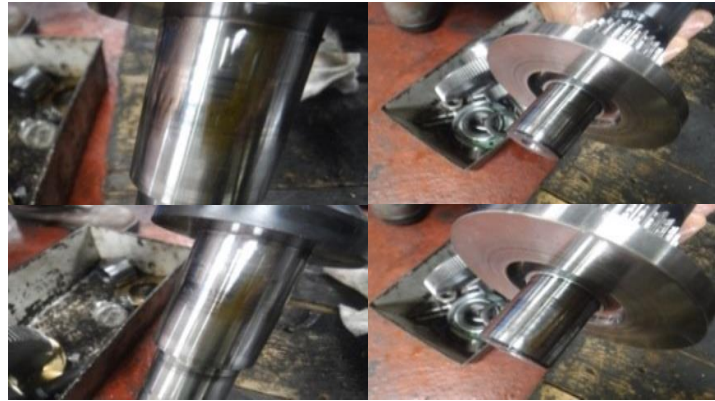
Fig. 5. Scratch on High Speed Shaft [10]

As with the impeller due to the low pump flow rate, the impeller subjected to pitting and bending, so that the bearing at the pump is subjected to wear and gear experiences a considerable backlash, causing instability movement on the high-speed shaft in the pump gearbox and produces scratches on the high-speed shaft lower and upper shaft bearing area [11]. As with the impeller due to the low pump flow rate, the impeller experiences pitting and bending.

Wear and scratch on the shaft causes vibration to the pump. Besides, the shaft also has a bent, due to the impeller experiencing unbalance so that the bent on the shaft also produces vibration. Damages that occur include the category of major damage, making the high-speed shaft must be replaced, the replacement of the high-speed shaft based on the LMV 322 instruction and manual specifications, it is stated that the high-speed shaft must be replaced if the outside diameter is less than 1.4960 inch [16]. And has clearances with a min limit on the upper high-speed shaft of 0.13 mm and a lower high-speed shaft of max 0.15 mm [11]. If it does not experience major damage and is still by API 610 standard, the shaft that is subjected to wear only needs to be checked on the worn part and polishing. But this is done for temporary repair [17].
