Appraisal of Flat Roof Defects in Commercial Buildings and the Remediation Techniques

Recently, there has been a trend in Malaysia where many buildings have been built with a concrete flat roof instead of the usual pitch roof. Some buildings have a combination of sloped roofs and flat roofs, where the flat roof surface is used to house facility equipment. Roof constructions in equatorial climates often suffer from surface-related problems, damage to the waterproofing membrane, and fractures in the roof parapet wall. These issues are caused by the hot and humid conditions that persist throughout the year. As a result, periodic maintenance is necessary to address these typical faults. This study aims to examine the different types of flat roof defects, as well as recommendation of remediation techniques. The methods employed for data collection include case studies and formal interview sessions with the professionals in the built environment. Based on the findings, there were few types of flat roof defects such as water ponding, membrane damage, blistering, cracking, vegetation growth, sagging and material degradation. Several rectification procedures were suggested, including imple

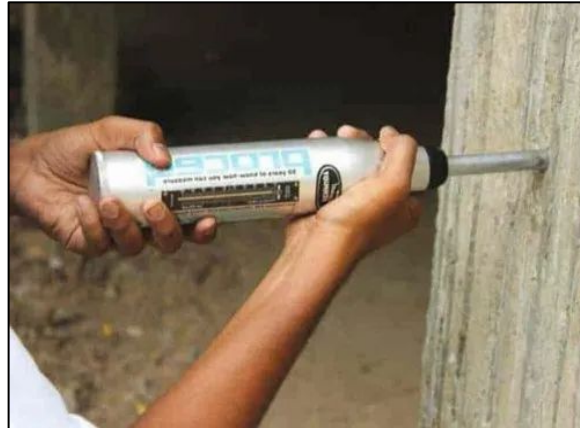
Fig. 1. Rebound hammer test

by this rebound value, often known as the rebound index or rebound number. Reduced strength and stiffness in concrete causes it to absorb more energy, which lowers the rebound value. In essence, the test uses the hammer's rebound to quickly assess the compressive strength of the concrete [24]. Figure 1 shows the setup for rebound hammer test.

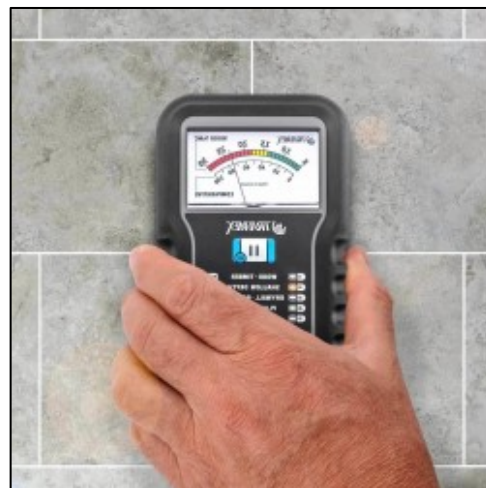
Fig. 2. Concrete encounter meter

The survey was conducted using concrete encounter equipment (Figure 2). The reason for this is because concrete encounter devices are capable of measuring the moisture present on the surface structure and accurately determining the moisture level. Furthermore, it has the capability to provide an immediate measurement of moisture content [25].

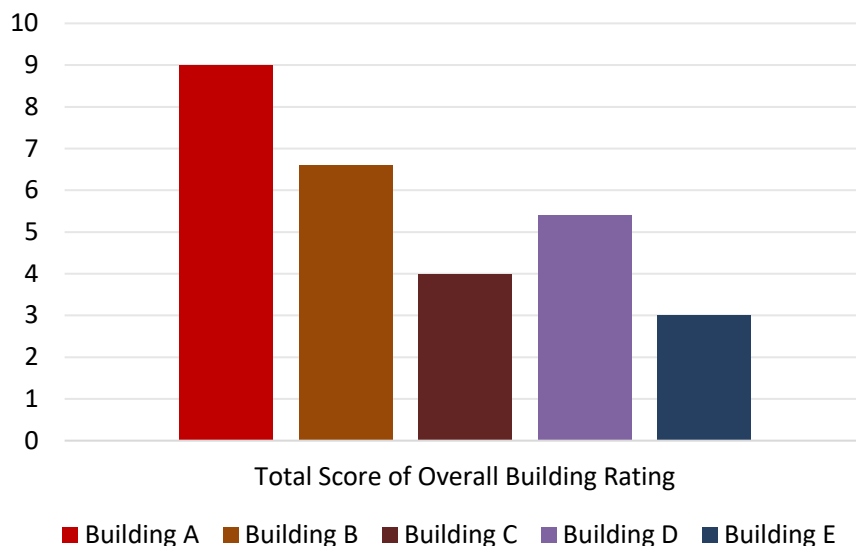
Fig. 3. Overall building rating of five case study buildings

There are several defects that have been identified and analysed at the case study building. Most of the defects at the case study building is water-pounding. The causes of each defect occur are different as it is based on the location and age of the building. Other than that, design of the structure also a main reason towards the possible defects occur. Table 2 shows the overall building rating table and Figure 3 demonstrates the analysis of building defects in several case studies.

Table 2 shows the overall building rating for five case study buildings. The highest total marks of building rating is Building A at 82 and followed by Building B at 46. Both case studies also have the same code for overall building rating, which is "fair" (yellow colour code), while Building C and Building E are in good condition (green colour code) at 20 and 14, respectively. Hence, it also shows that the lowest of total marks for building rating is Building E. However, Building D shares the same colour code for the overall building rating as Buildings A and B, which is yellow (fair). Figure 3 shows the overall building rating of five case study buildings. The highest overall building rating is Building A, total score at 9 and the colour code is fair which is in a condition monitoring categorized while the lowest is Building E at 3 which is under categorized good (green colour). Building B is higher than Building D at 6.6 and 5.4, respectively. These show that both buildings are in a condition monitoring category. Nevertheless, Building C total score is 4 and in a plan maintenance categorized same with the building E.

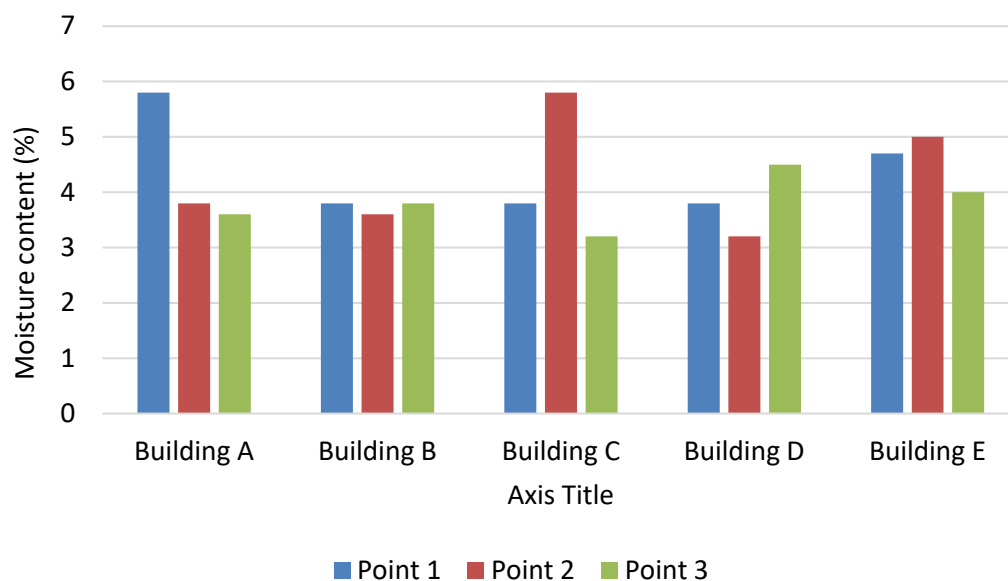
Fig. 10. Moisture content results

Table 4 shows the average moisture content of five case study buildings. The highest moisture content on the flat roof structure is Building E at 4.6%, as most of the defects on the rooftop of these buildings are water-pounding, which contributes to the moisture content, while the lowest moisture content on the flat roof structure is Building B at 3.7%. These show that building B has the fewest moisture defect problems. Building A and Building C also have the highest moisture content on the structure at 4.4% and 4.0%, respectively, while Building D has a slightly different number than Building B at 3.8%. Figure 10 shows the percentages of moisture content in a flat roof structure for five case study buildings. There are three-point tests for each case study in three different areas of defects. The highest percentages of moisture content for point 1 are in Building A at 5.8%, while for point 2, it is in Building C at 5.8%, and for point 3, it is in Building D at 4.5%. However, the lowest percentages of moisture content for point 1 are in Buildings B, C, and D, as these 3 case study buildings share the same percentages at 3.8%. For point 2, the lowest percentage is Building D at 3.2%, and Building C for point 3 is also at 3.2%.
