A Review on Evaluating the Optimization of Fibre Reinforced Polymer for Compound/Repair Clamp on Leaked Piping System using Computational Simulation

Ragu Chanthira Pillai¹, Ahmad Mubarak Tajul Arifin^{1,2,*}, Nor Adrian Nor Salim¹, Mohd Nasrull Rahman¹, Ishkrizat Osman Taib¹, Shahrul Azmir Osman¹, Shaktivell M. Letchumanan¹

¹ Faculty of Mechanical and Manufacturing Engineering, Universiti Tun Hussein Onn Malaysia, 86400 Parit Raja, Batu Pahat, Johor, Malaysia

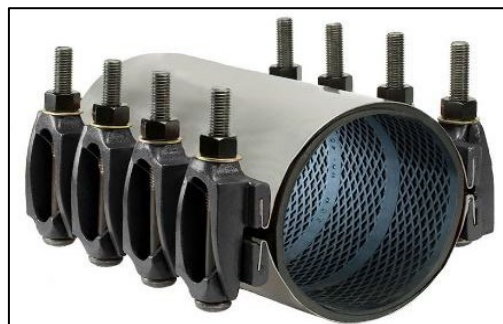
This is the most used type of clamp and provides a complete 360-degree seal around the pipe (Figure 6). It is typically used for repairing small leaks or breaks on pipes.

Fig. 6. Full circumferential clamp [21]

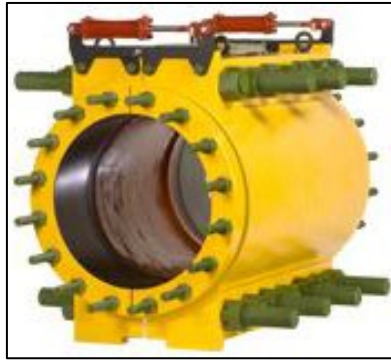
This type of clamp is designed for use on pipelines that cannot be shut down (Figure 7). It consists of two halves that are bolted together around the damaged section of the pipe, allowing for a quick and easy repair.

Fig. 7. Split repair clamp [18]
