Appraisal of the Aetiology and Pathology of Soil Settlement-Related Building Defects and Failures

Soil settlement; building defects; structural failures; sinkholes; rectification; foundation failure

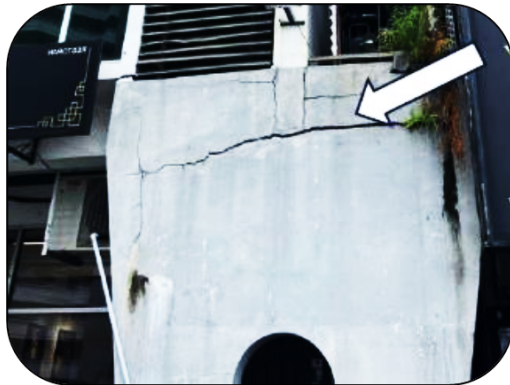
Figure 4 depicts an image of the building located in a commercial lot in Penang. Several studies have been conducted to determine the type of settlement based on careful examination of the defect. Empirical evidence indicates that the soil settlement seen is of the differential settlement type. Diverse solutions are those that exhibit structural fissures, lack of homogeneity, and protrusions where no fissures are evident. The fractures are characterized by their significant size and semi-horizontal orientation. They are typically seen in areas experiencing the greatest pressure and are commonly attributed to base shifting. Upon performing a site survey and visual examination, it has been determined that this store lot consists of two floors and is intended for commercial and business use. The likelihood of a crack occurring due to construction activity is minimal as there is no construction activity in the vicinity [20].

Fig. 4. Differential settlement at shop lot

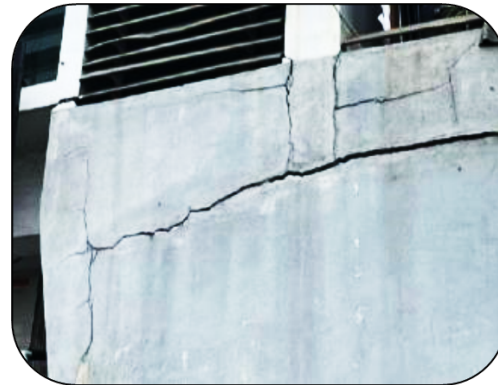
Figure 5 depicts a closer look at the cracks that form on the structure. The settlement of a building is influenced by various factors, including the type, material, and loadings of the building, the usability requirements, the integrity of the superstructure, the location of the structure in relation to other buildings, the rate at which settlement is occurring, and the distribution of settlement [2].

Fig. 5. Crack on shop lot structure

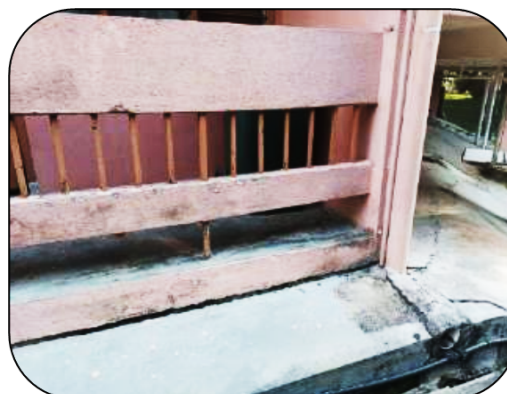
Figure 7 depicts a residential building specifically designed for dormitory purposes. The structure consists of four levels. This structure exerts a significant load and applies substantial pressure, resulting in stress on the earth. This investigation was carried out by visual examination in order to discover defects caused by soil subsidence. This problem can be identified as a form of differential settling. The building is situated in a gently undulating terrain and is near a lake. Due to its location within the school and in a student living neighborhood, no construction operations take place in this building.

Fig. 7. Dormitory residential building

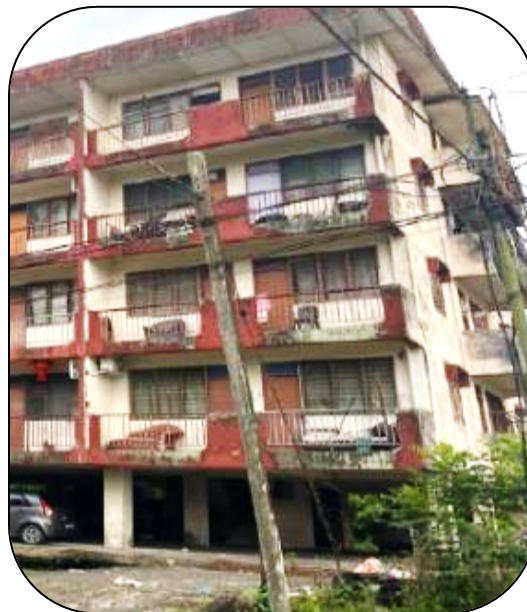
Figure 11 depicts an image of the building and structure of a flat building. This structure comprises a total of five levels, which encompass a designated area for parking vehicles. Upon examining the defects at the site, it is evident that the settling of the soil is consistent. This indicates that the ground subsidence is occurring evenly across the entire structure, without causing any cracks. Soil settlement within a building lead to ground subsidence because of underground displacement. The closeness of the building to the ditch region results in flooding during heavy rainfall. Strong currents during flooding can lead to soil erosion in the neighbourhood of buildings. This process of erosion can lead to the loosening or complete disappearance of the soil beneath the building, resulting in soil subsidence.

Fig. 11. External appearance of the flat

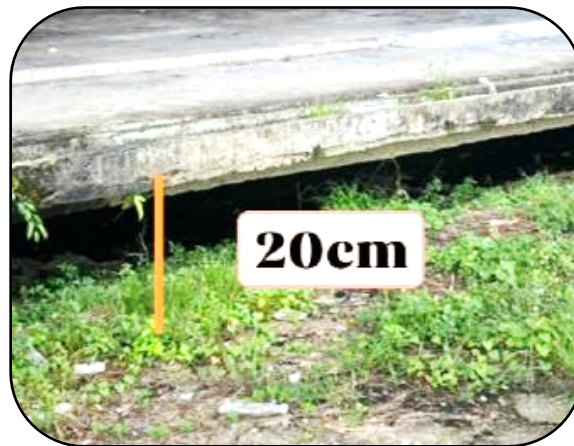
Figure 12 unambiguously illustrates the sinking of the ground beneath the building. The subsidence resulted from recurrent subterranean displacements caused by the extraction of water and mineral resources. Natural phenomena, such as soil compaction and the introduction of water to fine wind-deposited soil, can contribute to land subsidence. Ground sinking within a building can cause significant structural damage and jeopardize the overall stability of the structure. Consequently, this can lead to fissures in the walls, uneven flooring, and in extreme situations, complete structural failure. Promptly addressing ground subsidence issues is vital to maintain the safety and lifespan of the building. It should be pointed out that proper engineering methods can

Fig. 12. Ground subsidence within the building

avoid or reduce ground sinking within the building. These methods may involve utilizing deep foundations to ensure sufficient support, performing routine inspections to detect any indications of subsidence, and employing soil stabilization procedures to enhance the strength and stability of the soil. In addition, the installation of monitoring systems can be implemented to identify any alterations in ground movement and promptly initiate appropriate measures to mitigate additional subsidence. During the observation, the researcher takes precise measurements of the structural characteristics of the building's foundation in relation to the ground. The researcher approximated the vertical distance from the foundation to the ground as 20 cm as depicted in Figure 12. Rectify obstructed air ducts or install a drainage system if further supplementation is required.

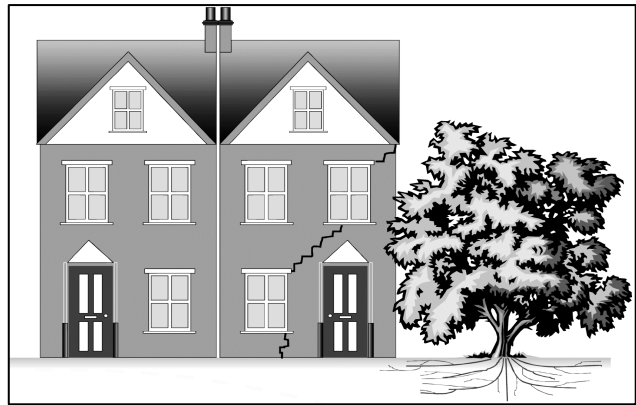
Fig. 14. Root of trees can lead to cracks on buildings

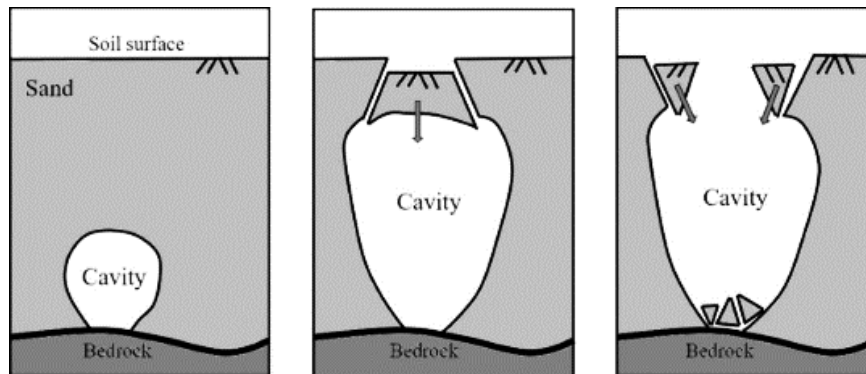
are present, most of these rocks are deeply buried and provide less of a hazard for most regions. Cavity collapse entails the generation of significant swirling and a notable augmentation in volatility and the boundaries layer thicknesses as demonstrated in Figure 16. When vapor canals collapse, they create huge swirling currents, and at the same time, swirling patterns emerge in the area where the cavity closes, and the flowing liquid circulates.

Fig. 16. Cavity collapse [30]

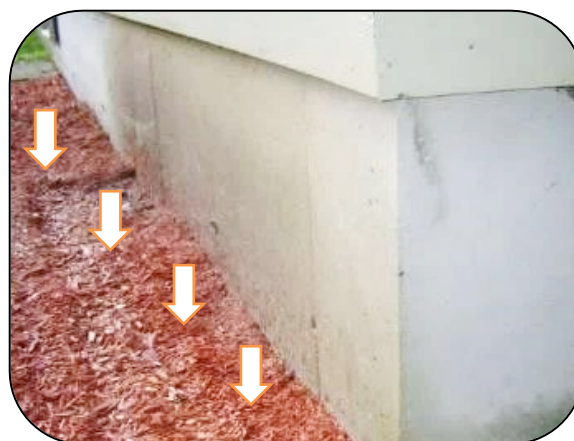
Occasionally, structures may undergo settlement when the soil beneath the foundation decreases in volume. This phenomenon can be attributed to the cumulative load exerted on the building over time and inadequate soil preparation as indicated in Figure 17. Gradual foundation settlement is a natural occurrence that commonly happens over a period. The weight of the structure itself can cause soil compaction over time, leading to increased soil density [30]. The settlement amount often fluctuates depending on the soil composition beneath your residence. Soils with high salinity, low cohesion, gypsum content, silt, and clay can contribute to increased settlement. On the other hand, bedrock will experience significantly less settling.

Fig. 17. Inadequate soil preparation may lead to settlement

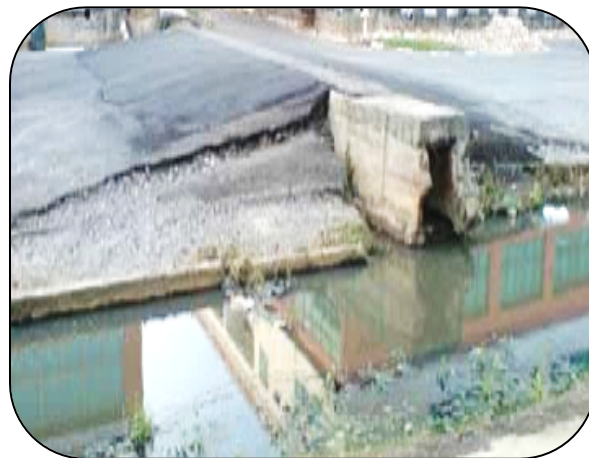
Alternatively, water can erode non-cohesive soil particles and cause the amount of soil to decrease, resulting in the sinking of bases [31]. Additionally, the poor drainage and road infrastructure may lead to serious ground settlement as shown in Figure 18.

Fig. 18. Improper drainage and roadways may result in ground settlement

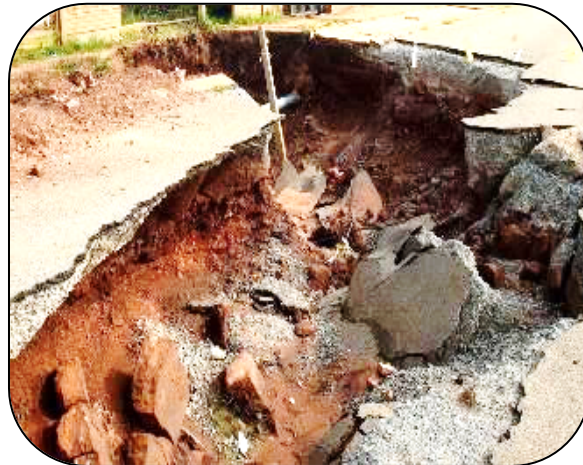
If there are sinkholes beneath the ground (Figure 20), the support for the house's foundations can also be compromised. Sinkholes commonly form in regions characterized by a karst topography, where the underlying rock is mainly composed of limestone or dolomite. These minerals undergo degradation when exposed to groundwater, leading to the formation of channels or voids beneath houses. These cavities might collapse and result in unstable areas beneath the foundation. Over time, the foundation will gradually sink into the ground that has caved in [33].

Fig. 20. Sinkholes may lead to settlement

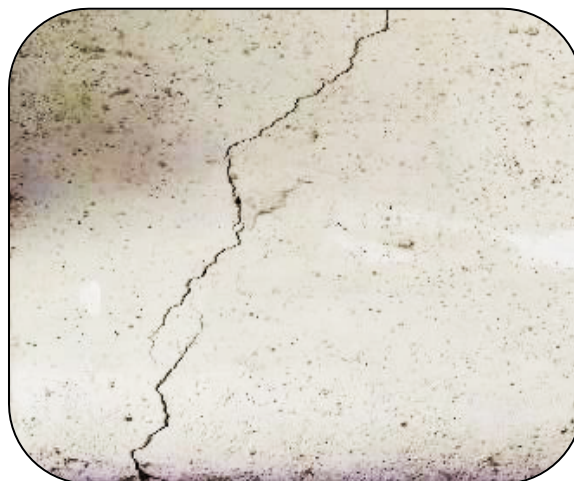
Hairline cracks (Figure 21) are the predominant indication of soil settlement, and they will manifest on the concrete flooring and/or wall structures regardless of whether the house has experienced typical, mild settlement or significant sinking problems. Hairline cracks are typically narrow, measuring roughly 0.125 inch in width, and exhibit equal alignment on the two sides [34-37]. Typically, one may include this into the usual base care routine to avoid the infiltration of dampness and eliminate any future concerns. These formations normally develop within the initial year or so following installation and do not increase in width or length as time passes.

Fig. 21. Hairline cracks

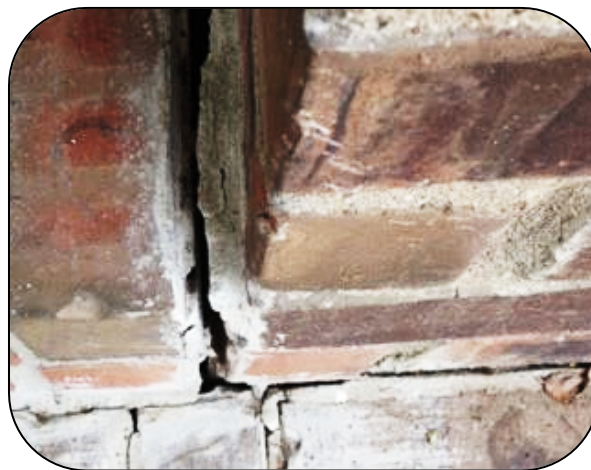
If fractures in the base of the ground or sidewalls expand to a width of 0.125 inch or greater [38-40], or if one of the sides elevates higher than the other, it is probable that you are experiencing a more significant settlements issue that is not of an unforeseen nature as displayed in Figure 22. Because of their great heat retention concentration, they are the focus of attention and undergo the isothermal process throughout the phase of change [41]. To address this matter and the accompanying complications, it is advisable to seek the assistance of a foundation repair expert who can implement a lasting resolution, such as basement refurbishment, supporting, or another type of stability or waterproofing.

Fig. 22. Foundation cracks

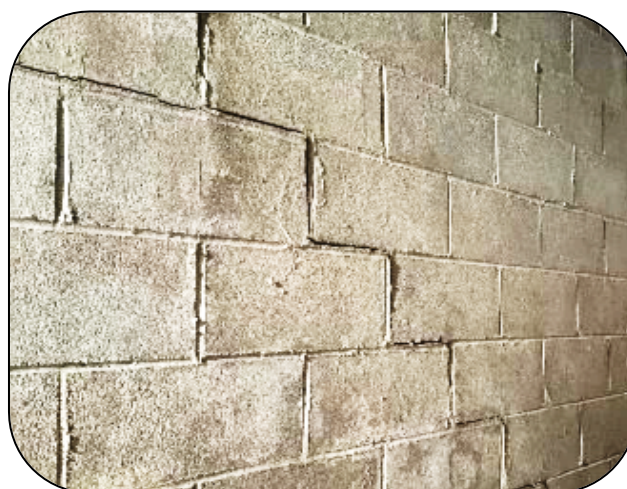
Stair-step fractures on the wall (Figure 23) typically occur while a section of the wall experiences a loss of rigidity from beneath, leading to settling and sinking into the soil. Cracks such as these are frequently a sign of structural degradation and necessitate a comprehensive repair method known as underpinning [42].

Fig. 23. Stair-steps fractures

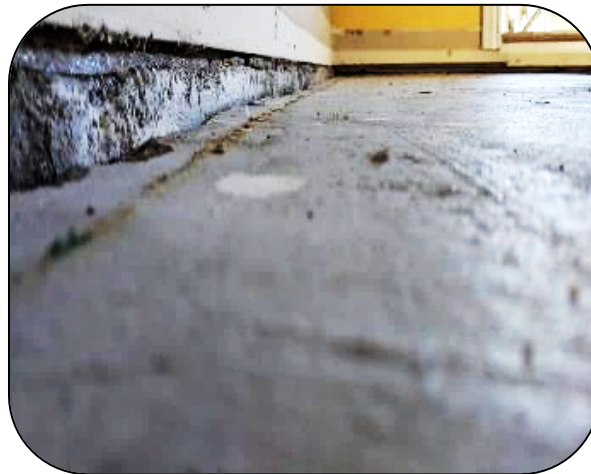
If the house's foundation experiences settlement, it can cause the flooring in the living room to slide inward or become unequal or undulating due to a loss of stability [43-45]. Figure 24 illustrates the sloping floor, whereas One may observe pronounced displacement in your everyday activities, or one could be using a leveling instrument to ascertain irregularity that is often imperceptible [46-48]. Severe structural deteriorations may also result from exposure to heat and elevated temperatures [49, 50]. The behavior of different types of concrete will vary as a result of their distinct engineering features.

Fig. 24. Sloping floor
