The Impact of Climatological Factors on the Multifaceted and Multisystemic Deficiencies of Building Anatomy

Md Azree Othuman Mydin^{1,*}, Norliana Sarpin^{2,3}, Rosmiza Mohd Zainol⁴, Ruba Odeh⁵, Mohd Nasrun Mohd Nawi⁶

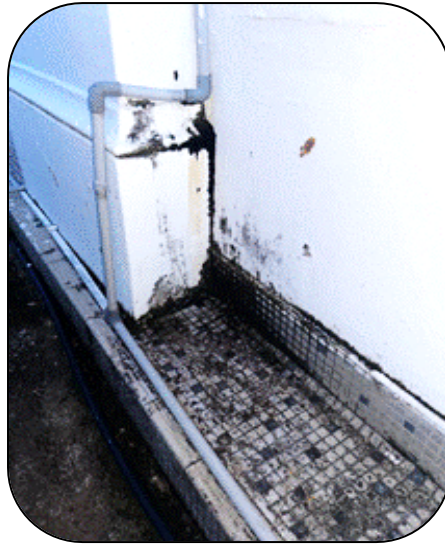
Fig. 1. Sign of fungal growth

Figure 1 shows the growth of the fungal organism that develops on the exterior surface of the structure. Observation methods are employed to ascertain the issues that arise. Researchers utilised a gadget known as a camera to document the state of the flaw. Upon investigation, the researchers discovered that the defective region was near the bathroom area and had a pipeline. Researchers have additionally discovered the presence of a minor pipe leakage that leads to the continuous and unyielding acceleration of fungal growth in the water. Additionally, scientists have discovered that the section of the wall that is directly exposed to rainwater is also a contributing element to the proliferation of the fungus. This has impacted the landscape in the surrounding area and resulted in the building becoming more disorienting. The proliferation of several fungus species leads to the development of a slippery surface, posing a potential hazard to individuals who have previously traversed the area.

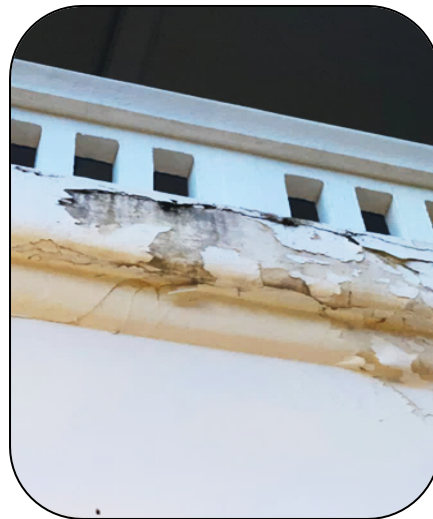
Fig. 2. Crack and dampness on the balcony

Researchers employed observational techniques to gather data on the abnormalities that transpired on the building's second level. The researchers utilise a tool, specifically a camera, to capture the circumstance in the form of photographs for enhanced clarity and traceability. Following the completion of the investigation, the researchers discovered the presence of moisture in the balcony area located on the building's second floor. The researchers discovered that the situation was quite unfavourable, with existing tiny cracks and dampness resulting from a lack of repair work as shown in Figure 2. This circumstance poses a threat to users in the area.

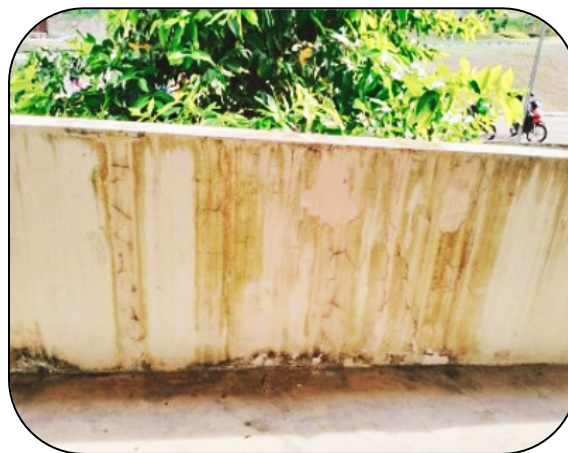
Fig. 3. Visible sign of dampness on external wall

Dampness in buildings is a prevalent problem that can result in harm to the structure, health risks, and reduced indoor comfort. Figure 3 shows a visible dampness occurred on the external wall. Rainfall, namely weather-related elements, significantly contribute to dampness. In places characterised by elevated humidity and frequent precipitation, such as tropical climates like Malaysia, structures are more prone to the infiltration of moisture and the occurrence of dampness issues. There are several inherent weaknesses in how weather leads to wetness.

- i. Ensure proper waterproofing of exterior surfaces, including roofs, walls, and windows.
- ii. Regularly inspect and maintain gutters and downspouts to prevent overflow and ensure proper drainage away from the building.
- iii. Seal any cracks or gaps in the building envelope to prevent water ingress.
- iv. Consider installing weather-resistant barriers and flashings to further protect vulnerable areas.

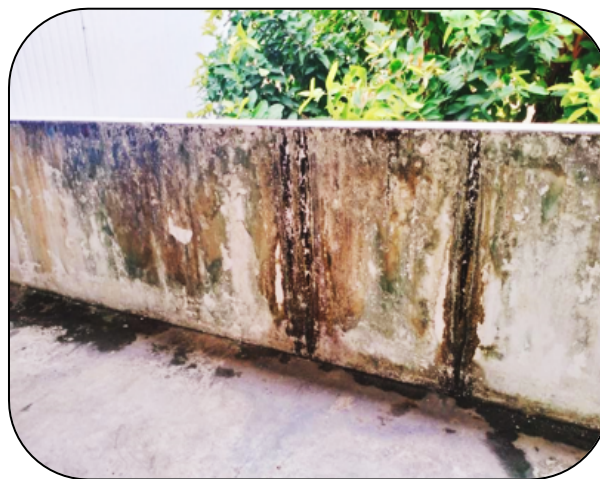
Fig. 4. Fungus and mold growth

The weather has a vital impact on generating favourable conditions for the growth of fungus and mould, which can pose substantial hazards to both the structural integrity of buildings and the health of the people inside. In areas characterised by high levels of moisture and frequent rainfall, such as tropical regions, the confluence of water damage caused by intense precipitation, raised humidity levels, and the dissemination of mould spores can result in extensive proliferation of fungi indoors [40]. There are certain inherent weaknesses in how climatic conditions contribute to the growth of fungus and mould as shown in Figure 4.

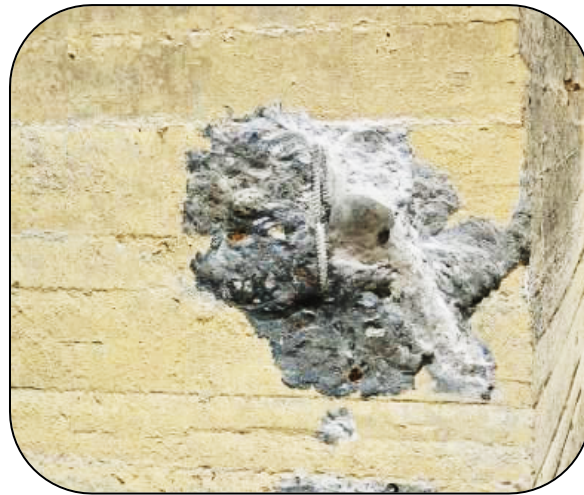
Fig. 5. Concrete surface deterioration

Intense rainfall can cause water damage, which can gradually weaken the construction materials of a building, resulting in deterioration, decay, and impaired structural strength as shown in Figure 5. Inclement weather conditions, such as torrential rainfall, can result in water infiltration into structures, resulting in the formation of leaks in roofs, walls, or windows. These leaks facilitate the presence of the moisture required for the proliferation of mould and fungi [41]. As moisture builds up in the building components, it provides an optimal habitat for mould spores to develop and proliferate.

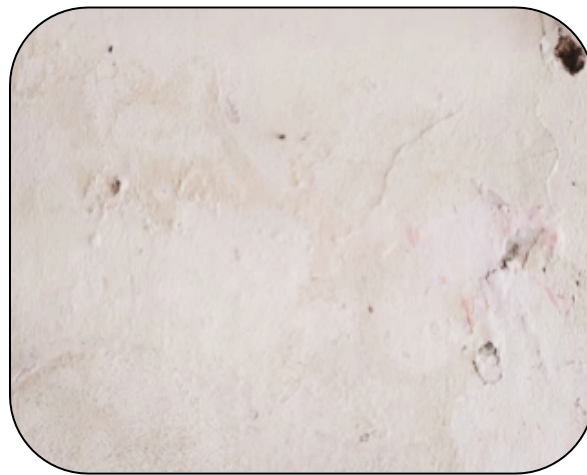
Fig. 7. Blistering on wall

Blistering, in the context of weather, commonly refers to the development of blisters on surfaces, such as paint or coatings, as a result of severe weather conditions. Figure 7 demonstrates the blistering that occurred on wall. Malaysia experiences a generally hot and humid environment. Blistering, a form of weathering, is caused by the impact of different weather conditions on surfaces [44]. There are several inherent weaknesses in how meteorological conditions lead to blister formation.
