# Journal of Advanced Research in Applied Sciences and Engineering Technology

## Assessing the Effects of Insect Attacks on Buildings and Practical Corrective Measures

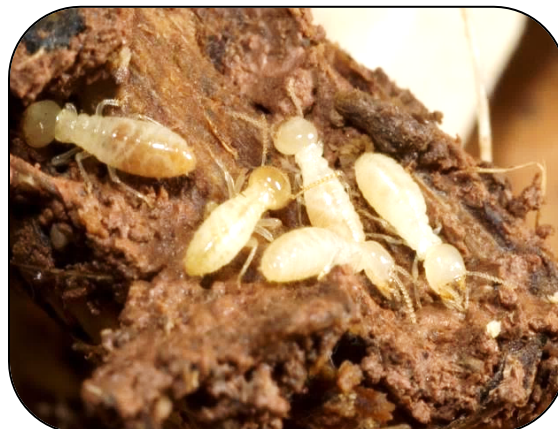
**Fig. 1.** Termites

Termites (Figure 1) also referred to as ‘white ants’ are highly organized insects that establish complex social structures. In fact, they have no connection whatsoever to ants. Two termite species that are of conservation significance are soil termites and dry wood termites. One species constructs its nests at ground level, whereas another species is capable of flight. Termites pose a significant threat to timber structures. If not controlled, they have the potential to cause significant harm due to their consumption of cellulose, a substance found in wood. Termites have the ability to excavate the interior of beams, posts, and other wooden components of a log structure, thereby diminishing its structural integrity. Termites are prone to tunnelling through aged or untreated wood, creating holes and using them as pathways, particularly within walls. Furthermore, termites also migrated between the inadequately constructed foundations. Termites have the ability to infiltrate gaps between the foundation and walls of buildings, even when these areas are not suitable for them to feed on. Termites will significantly weaken the structural integrity of the wood. Signs of termite infestation are visible on the extensions of foundations, walls, timber columns, rafters, beams, and other structural elements [14].

Furthermore, an additional consequence of termite infestation is the production of a noxious odour in both the load-bearing and non-load-bearing components of structures, resulting in the formation of blisters or discoloration on walls, columns, and other surfaces [15, 16]. The reason behind these termite attacks is that once their leaders or colonies discover a location with a potential food source, they gradually consume all the edible wood, leaving only the exterior layers behind [17, 18]. The rationale behind preserving these outer layers is to offer a habitat for the termites residing within the wood. Figure 2 shows the effect of termite attack on wooden flooring while Figure 3 demonstrates termite attack on timber wall. According to Figures 2 and 3, termites mostly remove palatable wood, which will provide space to fill the remaining thin outer layer and maintain its rigidity. The massive number of mound-building termite nests makes their attacks on timber construction extremely destructive. They usually eat the nutrients in wood, which leads to the integrity of the wood itself being low in terms of strength [19, 20].

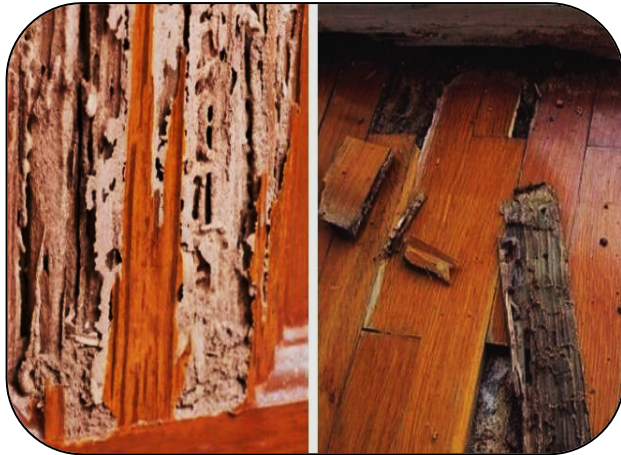
**Fig. 2.** Termite attack on wooden flooring

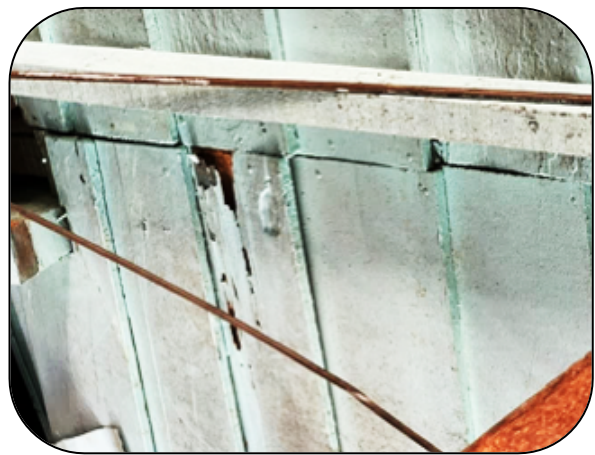
**Fig. 3.** Termite attack of timber wall

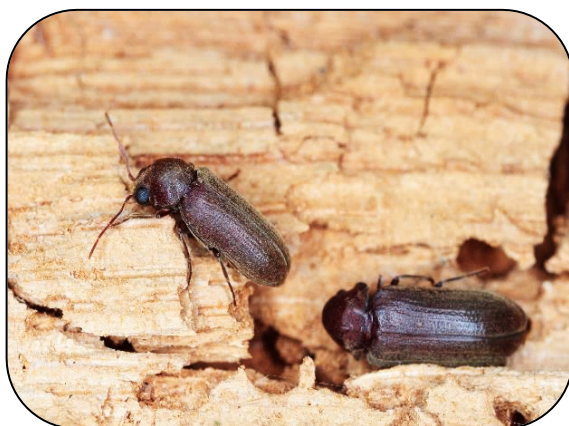
**Fig. 4.** Wood-boring beetles

Wood boring beetles (Figure 4), sometimes known as boring beetles, belong to a genus of insects that feed on wood by burrowing into it. Upon reaching maturity, the larvae of this species undergo a transformation into fully-developed beetles. However, before to this stage, they reside within the wood [21]. The term "woodworms" is the most used word for furniture bugs, however there are other names as well. Several kinds of beetles, such as deathwatch, longhorn, and powder post beetles, tunnel into wood to deposit their eggs [22]. Upon consuming the wood, the larvae undergo metamorphosis and mature into adults, constructing galleries and tunnels. Over a period of time, this activity might potentially compromise the strength of the wood and lead to structural issues [23]. The beetles excrete frass through the holes they bore into the affected wood. This material commonly accumulates in fissures or below fissures in structures. Frass can vary in texture from exceedingly fine to rough.

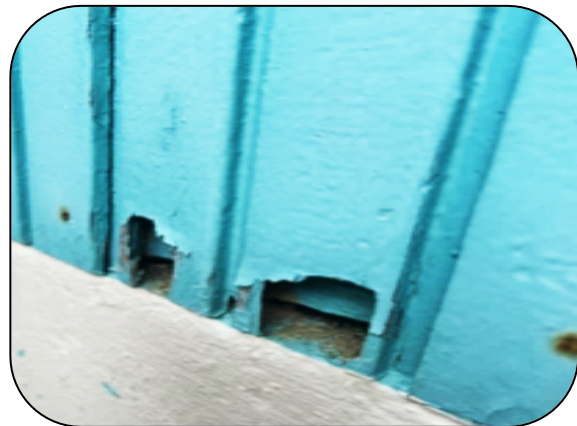
**Fig. 5.** Bore-holes defects

According to Figure 5, wood-boring beetles typically infest structural softwoods. Contrary to its name, it is often a concern with newer projects that utilize wood that is contaminated. Wood that is not properly treated, kiln-dried, or stored for a long time becomes susceptible to damage. This insect readily infests structural timbers. Most wood borers typically produce raised, circular holes, however they may occasionally make oval or semicircular holes. The dimensions and morphology of the cavities that appear can aid in distinguishing clusters of beetles. Wood boring beetles specifically target subflooring, hardwood floors, interior trim, joists, sills, and beams for their assaults. Potential targets may encompass tool holders, hardwood furniture, staircases, and other wooden objects.

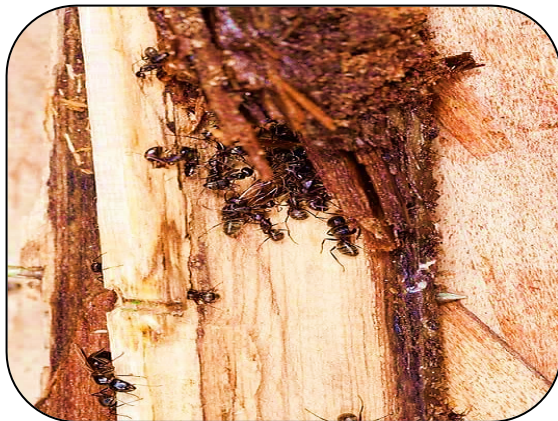
Fig. 6. Carpenter ant

Carpenter ants (Figure 6) are insects that primarily inhabit and construct their nests in wooden structures, both outdoors and indoors. These ants destroy wood to create empty spaces where they can construct their nests. Carpenter ants, unlike other insects, often do not actively attack or consume wood. Instead, they tend to undermine the structural integrity of wood and mostly infest trees that are already damaged. Carpenter ants construct colonies on the property when they discover a source of food. If this incursion is not swiftly dealt with, it rapidly escalates into a major infestation [24]. After excavating holes in a direction opposite to the natural pattern of the wood, they transport the wood shavings to a separate location that is not near the wooden tunnels. Homeowners may find it more challenging to locate their nest following the removal of wood chips, since only a little oval hole remains within the wood.

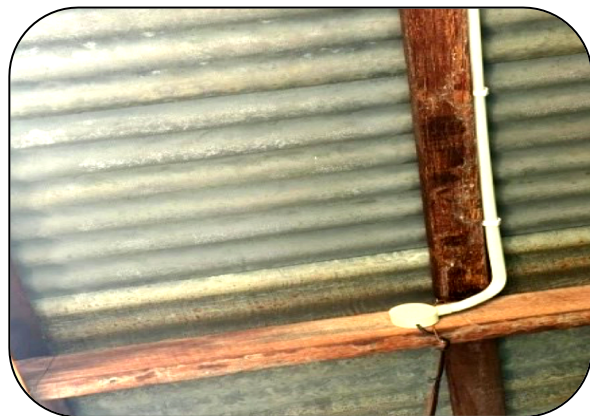
Fig. 7. Damage due to carpenter-ant attack

According to Figure 7, carpenter ants will exploit any opening in the structure. Carpenter ants have the potential to significantly compromise the structural integrity of buildings. Long-standing infestations might lead to significant repercussions. While termite infestations are more destructive than ant infestations, it is still essential to take preventive steps to prevent structural collapse caused by the ants' tunnels in our homes [25]. These critters possess the capability to cause significant damage to structures, however they are typically more of a nuisance than a structural concern.

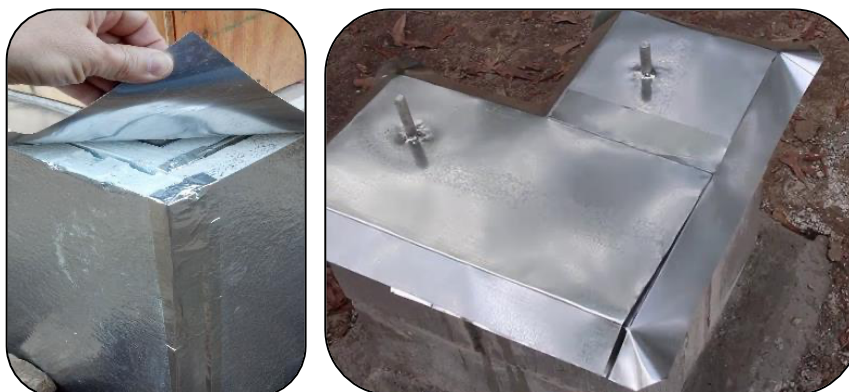
Fig. 8. Termite shields

Foundations are built using resistant materials such as brick, steel or concrete slabs to make termite tunnels visible. All foundation walls and columns must be installed with termite shields (Figure 8) made of durable materials such as crushed stone, steel casing or stainless-steel mesh. Termite shields should be installed with a protrusion of 2 to 3 inches beyond the wall on all sides as shown in Figure 9. Soil treatment can result in the concentration of toxic materials in the soil

surrounding the foundation and columns [27]. Durable chemicals are no longer registered for such uses, so modern chemicals must be reused to maintain protection. A network system or hand-sprayed chemicals can be used to reapply, with special pipes hidden inside the building for reinforcement.

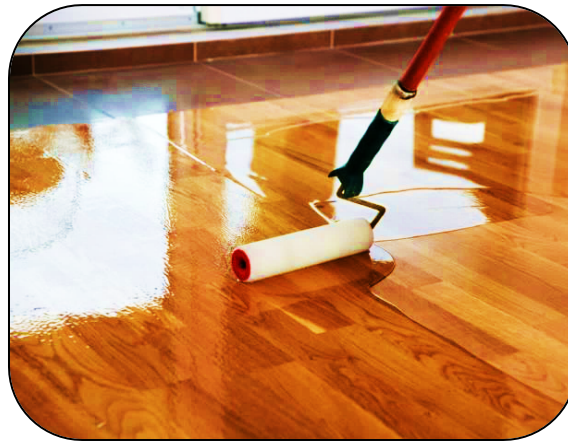
**Fig. 10.** Protective layer of polyurethane

Wood beetle attacks are not always prevented by the concealed feeding behaviour of larvae. This is a risky practice [30]. The risk of infection can be reduced by using seasoned wood in construction and inspecting the wood as well as other types of wood before buying. Sealing exposed wood surfaces with a protective layer of polyurethane (Figure 10), varnish or paint also prevents species that can re-contaminate the structural wood from spawning. Additionally, firewood must be debarked, stored outside, and brought home only immediately before use.
