Journal of Advanced Research in Applied Sciences and Engineering Technology

A Study of Building Structure Resilience to Seismic in the Batu Pahat Area using Rapid Visual Screening Method

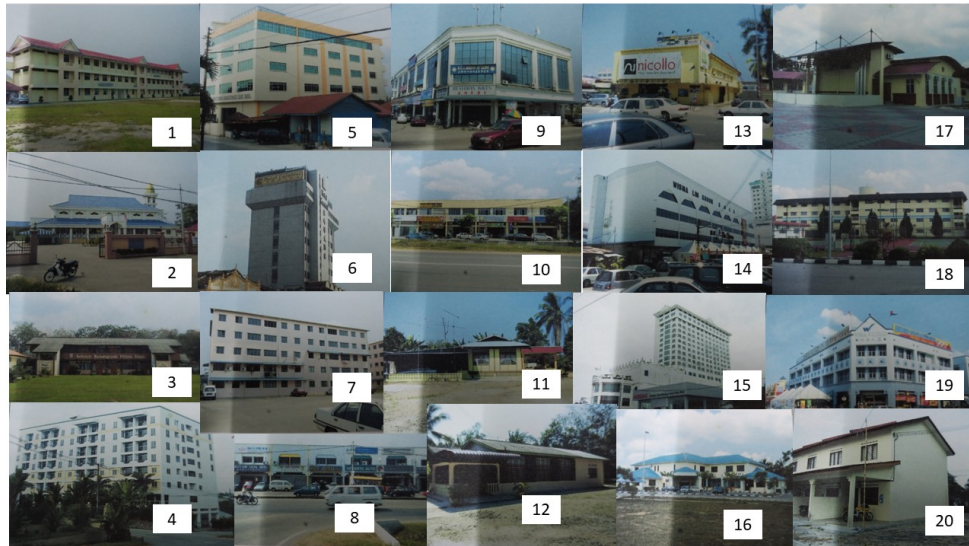
Fig. 2. Sample of data collection for the selected buildings

Furthermore, a total of 20 types of buildings in this area were selected to be modelled in this study. In this methodology, a total of 20 scattered samples were taken, representing a diverse range of building types, which included university buildings, residential structures, mosques, hotels, commercial shop lots, and old wooden houses. This diversity in the sample set was designed to yield a wide range of results, allowing to assess the varying levels of sustainability when subjected to earthquake scenarios. Despite on external characteristics such as their shape, height, and location, this selection process was informed by various factors, including accessibility, the functional status of the buildings and occupancy. These considerations were taken into account to enable to assess the wide spectrum of sustainability levels when these buildings are exposed to earthquake which are shown in Figure 2 below. Data related to the Batu Pahat district will be collected from several agencies involved as follows:

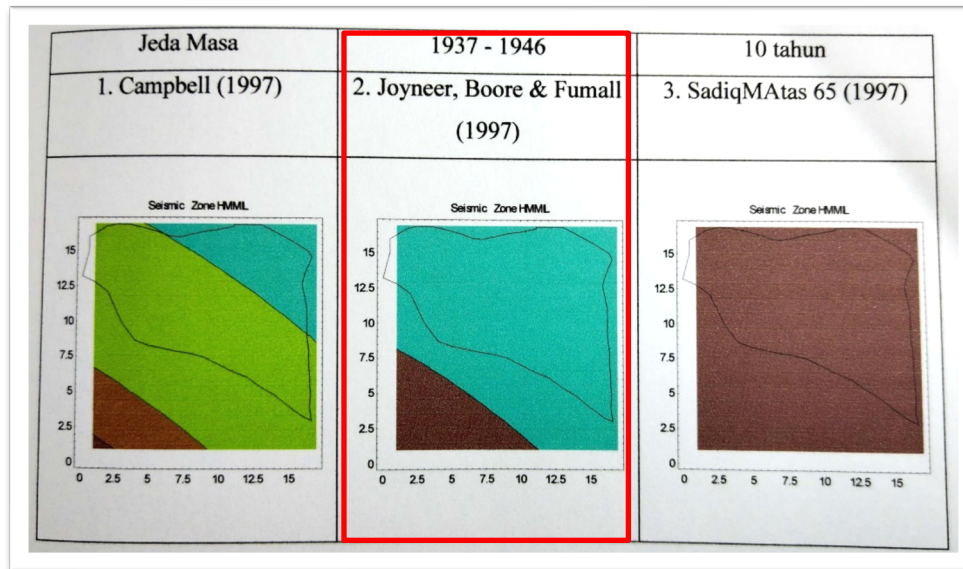
Fig. 3. The seismic zones for seismic assessment of the Batu Pahat District

The acceleration maps for the Batu Pahat District based on a 100-year earthquake. The colour shown on the acceleration map represents the seismic zones, with darker colours indicating higher seismic zones. Malaysia is divided into three regions based on their level of seismic hazard: Peninsular Malaysia has low hazard (0.05g-0.07g), Sarawak has moderate hazard (0.07g-0.09g), and Sabah has high hazard (0.15g-0.165g). In this case, g refers to gravitational acceleration, which is 9.81 m/s^2 [24].

After applying this program, a total of 30 equations were produced. The results obtained indicate that the maximum ground acceleration for the Batu Pahat District is approximately 0.0553 g, based on the Joyner *et al.*, [25] equation. This result is shown in Figure 3, and falls below the low-intensity seismic zone. As the Batu Pahat District is in a low-intensity earthquake zone, to conduct building assessments, the ATC-21 form should be used with the Low Map Area form.

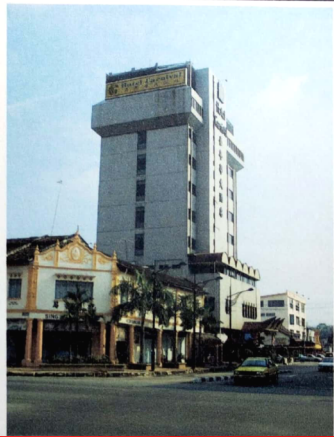
Fig. 4. Sample ATC-21 Assessment Form

$$4.0 \text{ (score)} - 1.0 - 0.5 \text{ (modifier)} = 2.5 \quad (1)$$

Hotel Carnival

Address: *Jalan Fatimah, Batu Pahat.*
 Zip: *83000*
 Other Identifiers:
 No. Stories:
 Year built:
 Inspector: *Fahir*
 Date: *Jan 2005*
 Total Floor Area (sq. ft):
 Building Name: *Hotel Carnival.*
 Use: *Commercial*
 (peel – off label)

* =Estimated, Subjective		SL3	-0.6	-0.6	-0.6	-0.6	-0.6	-0.6	-0.6	-0.6	-0.6	-0.6	-0.6	-0.6
Or Unreliable Data		SL3 & 8 to 20 stories	N/A	-0.8	-0.8	N/A	-0.8	-0.8	-0.8	-0.8	N/A	-0.8	-0.8	-0.8
DNK = Do Not Know		FINAL SCORE						2.5						
COMMENTS														
														Detailed Evaluation Required? YES/NO

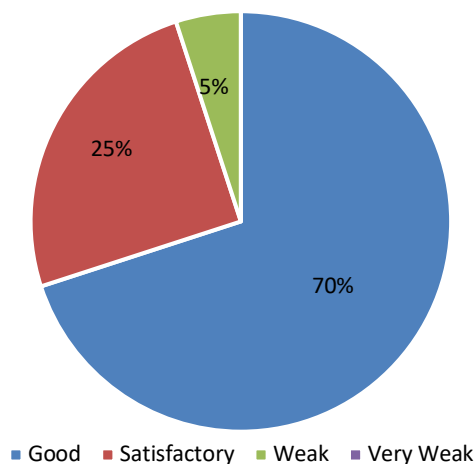
Fig. 5. Overall percentage of 20 sampled building

The seismic resilience levels of 20 sampled buildings are presented in Figure 5, which was generated based on the data provided in Table 7.

Resilience Classification	Percentage (%)
Good	70
Satisfactory	25
Weak	5
Very Weak	0

According to the study, it was found that the majority of buildings in the study area were in good condition, with 70% of the 20 assessments indicating that they were in good shape. This means that out of the 20 sampled buildings, 14 were classified as not being high rise structures and did not have soft story or torsion issues.

However, the remaining 25% of the assessments, which represents 5 sampled buildings, were only rated as satisfactory due to being high rise structures. Additionally, 5% of the buildings, which represents 1 sampled building, were identified as weak due to having soft story, being high rise, and having torsion issues. This is a concerning trend, especially given the increasing risk of earthquakes in our country.
