Analysis of High Vibration Causing 211-P-25A Centrifugal Pump Damage in Hydrocracker Process

High Vibration; Internal Recirculation;
Cavitation; Centrifugal Pump

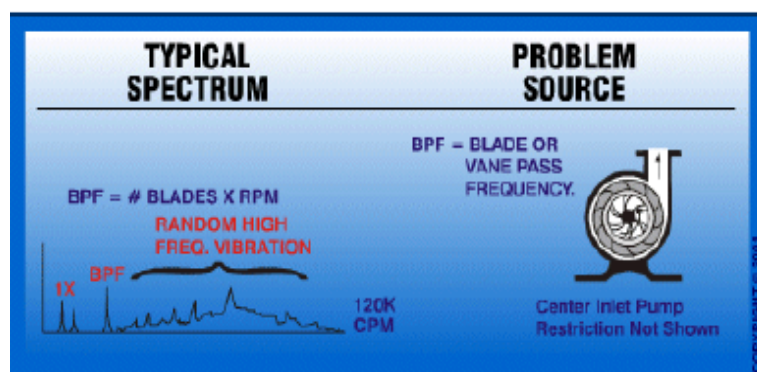
Fig. 3. Typical cavitation spectrum [12]

Then, the spectrum results are compared with API 610 and Technical Associates regarding the typical spectrum that occurs. Cavitation generates higher random frequency broadband energy, which usually coincides with the harmonic frequency. Cavitation is the phenomenon of changes in the vapor phase of a liquid that is flowing because the pressure decreases to below the saturated vapor pressure [13]. On the pump, the part that often experiences cavitation is the suction side of the pump [14]. Cavitation can be very damaging to the internal pump if it is not repaired, and this cavitation is an effect of repetitive internal circulation [15]. Figure 3 shows typical cavitation spectrum

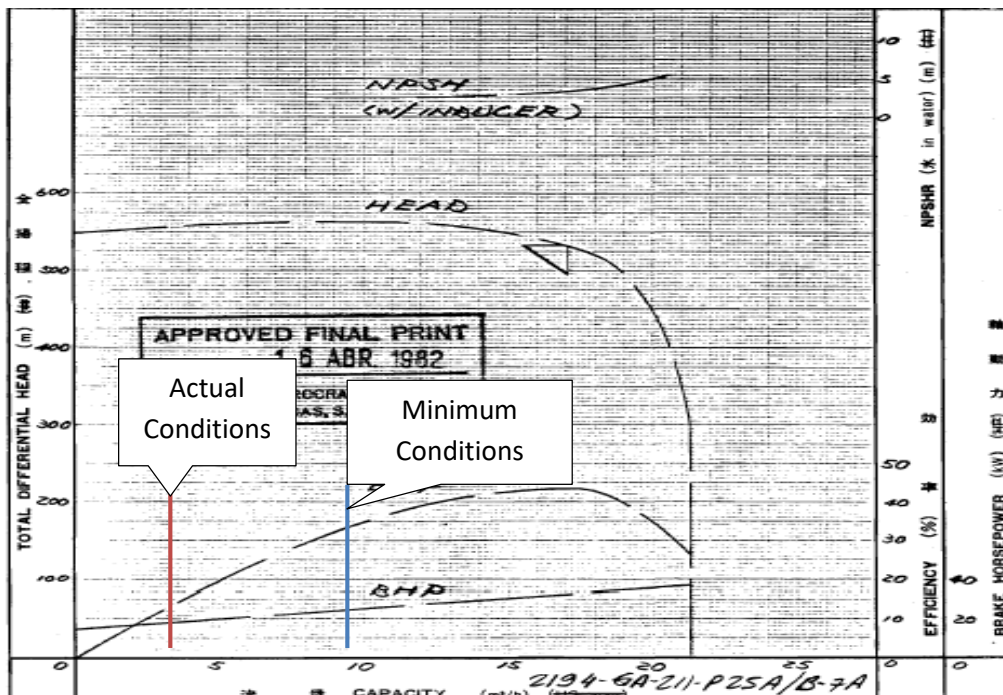
Fig. 6. Effect of flow rate on pump performance [9]

Damage to the 211-P-25A pump is caused by internal circulation that repeatedly occurs, causing damage to the impeller and high-speed shaft components. This damage will result in pump performance that is not optimal and reduce pump efficiency. This is by the flow rate produced because the pump's damage is obtained a flow rate of 2.67 m³/h, which should have a minimum flow of pumps of 8.6 m³/h [18]. So the pump performance will decrease. Figure 5 shows Scratch on High Speed Shaft, and Figure 6 shows effect of flow rate on pump performance, and simple flow chart to analyze the high vibration causes shown in Figure 7.

To eliminate low flow, additional flow can be done by fully opening the line bypass control. Then, if the flow requirement is above the minimum flow, additional flow is done manually by closing the line spill back after the maximum flow control FC-522 is no longer achieved [18]. Furthermore, the addition of instruments to the 211-V-23 vessel with auto stop with a minimum suction head of 3.5 m according to the pump NPSHr [19]. To increase pump efficiency, it can re-rate the pump impeller according to operational needs. This can be done with affinity law, to be able to change the flow and still maintain pressure to the system from the pump.
