Effect of V-shaped Side Groove on Shear Lips Formation of Aluminium Alloy 6061 by Charpy Impact Test

ABSTRACT

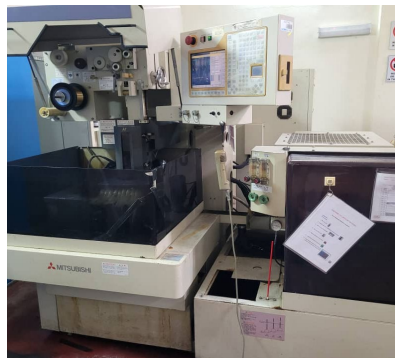
Fig. 1. (a) EDM wire cut machine and (b) AA6061 specimen with side grooves

Wired electrical discharge machining (EDM), which is shown in Figure 1(a), was used to create precise notches and side grooves (see Figure 1(b)) by cutting and removing material. This involved passing an electrically charged wire through the workpiece, causing electric discharges that shaped it horizontally. The Mastercam app was used to draw the notch and side grooves, and G-code programming was established based on their dimensions. AA6061 samples with notches and V-shaped side grooves were obtained with everything set up.

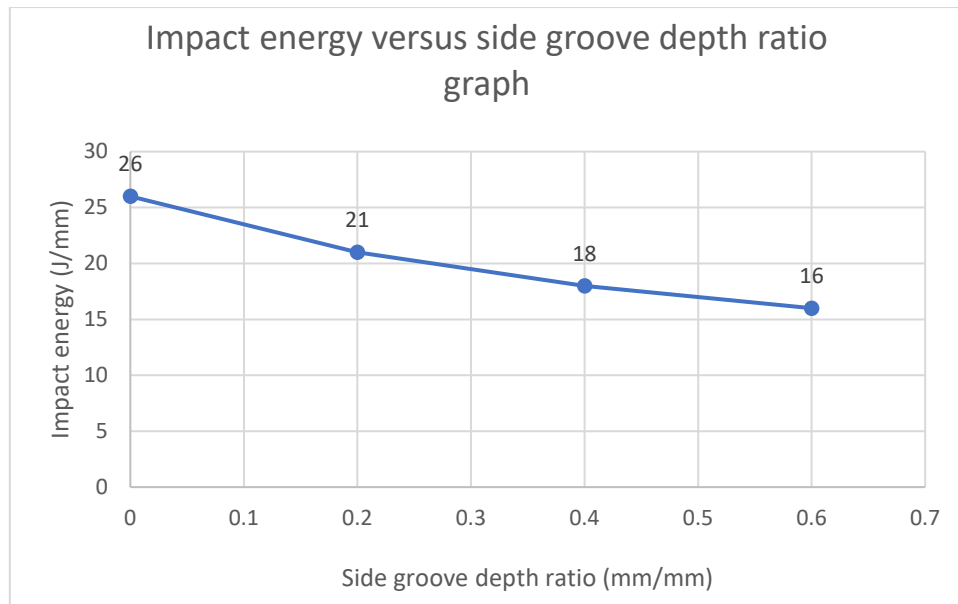
Fig. 3. Graph of impact energy versus side groove depth ratio

Data was collected in this study using a Charpy impact test machine at room temperature for samples with varying side groove depth ratios (see Table 4). The data shows a pattern where the side groove depth ratio increases from 0.0 to 0.6 mm/mm, and the impact energy decreases. As the ratio of side groove depth to groove length increases, the material or structure becomes less resistant to impact forces. Additionally, as the side groove depth increases from 0 to 3 mm, the impact energy also decreases. This implies that deeper side grooves reduce impact resistance [10]. Therefore, the table suggests that increasing the side groove depth or the depth ratio weakens the material or structure's ability to absorb energy during impact, resulting in lower impact energy [11]. As we know, the lower a metal absorbs the energy to fracture, the closer it is to brittle behaviour [12]. Figure 3 shows the impact energy gradually decreased as the side groove depth ratio increased, indicating a decrease in the specimen's ability to absorb impact energy.

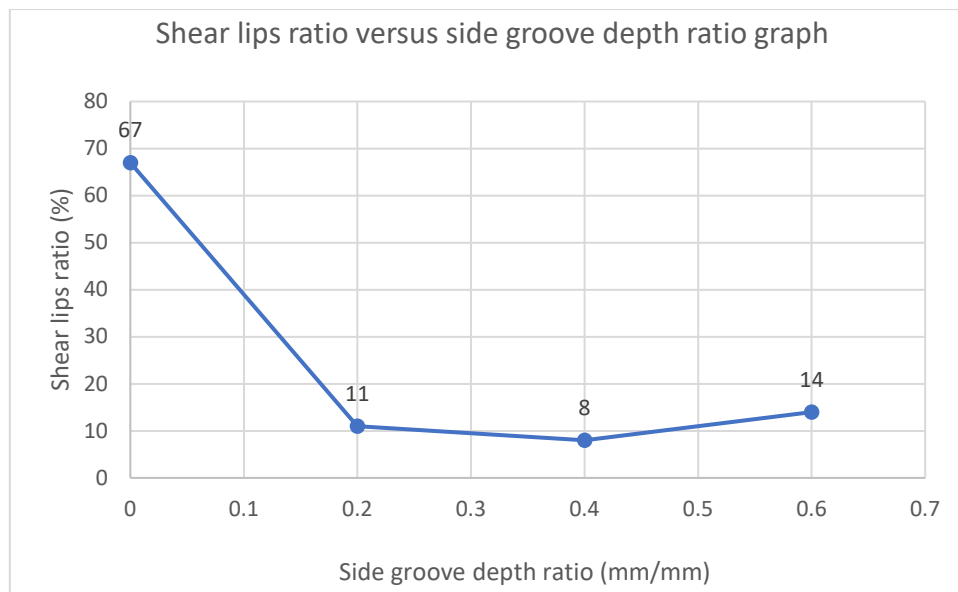
Fig. 4. Graph of shear lips ratio versus side groove depth ratio

However, the steep graph shown in Figure 4 indicates that plastic deformation is greatly affected and can be reduced by inducing a slight depth of side groove. The graph also illustrates a decreasing trend in the shear lips ratio as the side groove depth ratio increases, suggesting a transition from ductile to brittle fracture as the depth increases. Smaller shear lips ratios indicate a higher likelihood of approaching brittle fracture. Energy absorption is a key factor in Charpy impact testing and provides insight into specimen fracture, assessed after the specimen was fractured into two pieces. A smaller shear lips area in Charpy impact tests signifies reduced plastic deformation near the groove or notch region. It indicates the material has lower ductility and limited ability to deform plastically before a fracture occurs [15]. This implies decreased energy absorption capacity and an increased likelihood of brittle fracture behaviour as the side groove depth ratio increases [16].
